# THE LAST SECONDS OF FLIGHT OF THE TU-154M IN SMOLENSK ON 10<sup>TH</sup> OF APRIL 2010

Glenn Arthur Jørgensen

## Abstract

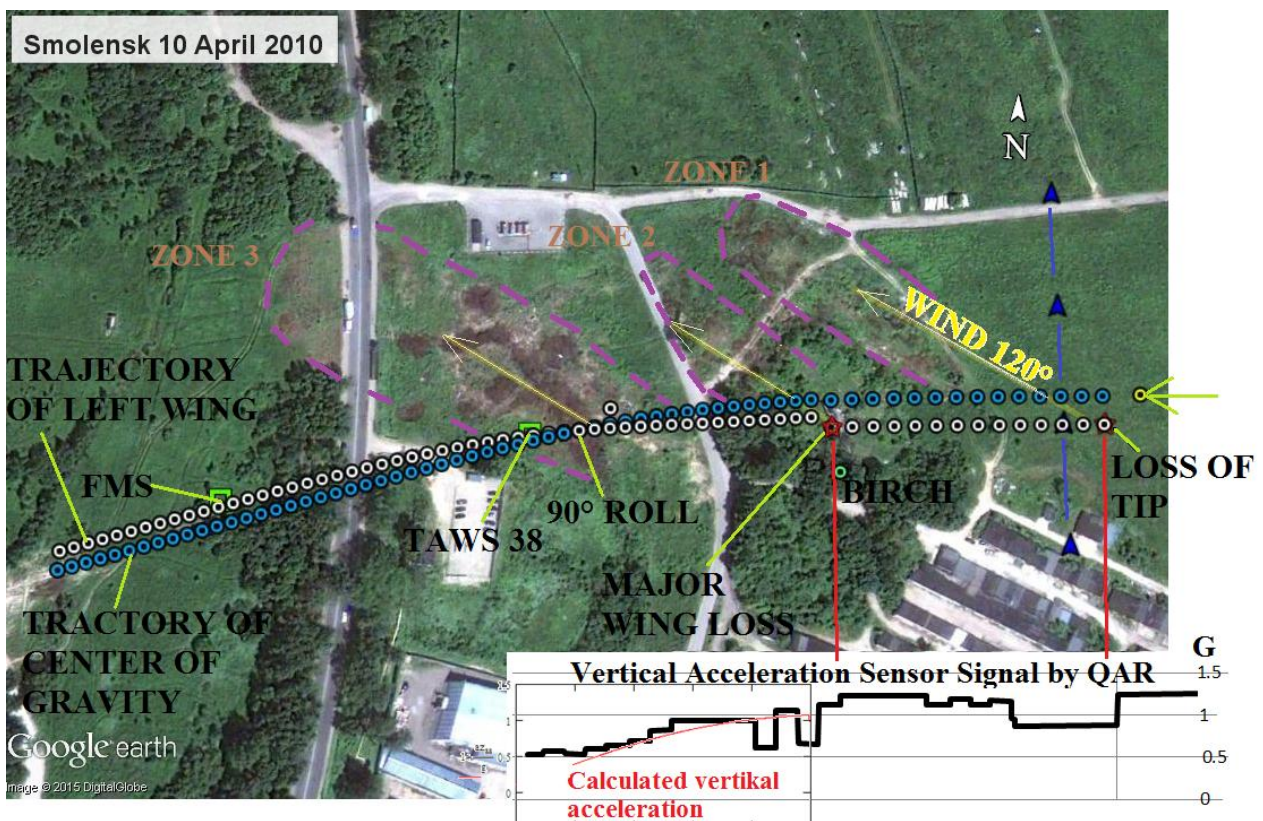
**Fig. 8.** The calculated trajectory for the center of gravity (blue) and the left wing tip (white). The satellite picture is from the 25th of June 2010 (two months after the crash). Notice the distinct and significant damage of vegetation in the three areas (zone 1, zone 2 and zone 3) circled by the dashed lines. Adding the recorded vertical acceleration signal by the Polish QAR (black line) and the wind direction of  $120^\circ$  show the clear correlation between the three distinct areas of vegetation damage to the approximate positions of the loss of the wing tip, loss of additional wing area and a third explosion emptying the center fuel tanks and triggering the TAWS 38 recording. In agreement with the location of the damaged vegetation patterns the loss of the wing tip took place 100m - 120 m earlier than the birch tree just before or after the exit of the middle marker zone (blue triangles). The distance between the patterns corresponds to the flying distance between the two events (loss of wing lift) as recorded by the Polish QAR black box. The final calculated velocity ( $V_z=23$  m/s) towards the ground at the "FMS" point agrees well with the recorded value of  $V_z=22.2$  m/s. The scenario can also explain why wing parts are found earlier than the birch tree and in a belt along the highway north of the trajectory. The calculated vertical acceleration (red line of bottom fig.) shows same characteristic decline as the recorded signal.

The damaged vegetation (see zone 1 and zone 2 of fig. 8) fits with fuel/hydraulic oil poisoning of the vegetation by the fuel and hydraulic oil dispersed from the plane's wing at each wing loss and carried by the  $120^\circ$  wind. The third and largest zone (zone 3 of fig. 8) of damaged vegetation occurred down wind from the region the plane's roll angle passed through  $90^\circ$  at the position of TAWS 38. Normally the control system will detect a landing event as the moment when the wheels are pushed towards the wings rather than hanging by their own weight. A plane rotated  $90^\circ$  or more will experience much higher sensitivity towards mechanical disturbances as the gravitational force is not pulling the wheels away from the wing. The position and size and shape of the third damaged zone of vegetation points towards a sudden release of a relative large amount of fuel. Assuming some scattering of the dispersed fuel due to the wake surrounding the plane, the width of zone 3 of about 50m suggests a fuel release with less than 0.4s. This fact and knowing the two earlier zones were caused by such sudden events leads to the conclusion the third zone was the result of the sudden release caused by a third explosion. The false detected "landed" event at the point of TAWS38 agrees with this hypothesis as a result of the mechanical disturbance associated with the explosion when the plane roll made the landed detection system sensitive for such disturbances. The calculated wing trajectory ends at the position of the wing ground trace as shown in Fig. 7, and the trajectory of the center of gravity ends at the correct location passing through the final recorded three independent GPS positions. These field data thereby support the calculated trajectories. Fig. 7

The three distinct damaged areas of vegetation as seen on the aerial photo of the 25th of June 2010 a couple of months after the crash correlate well with the expected location of wing losses (zone 1 and zone 2 of Fig. 8) when taking the direction of wind of 120° into account. Zone 3 is by far the largest zone of damaged vegetation, and the width and shape of this suggests a third explosion releasing a significant amount of fuel while the plane had about 90° rotation. The rotation of the plane increases the sensitivity of the landing sensor located at the wheels, and can explain why the TAWS 38 recording was triggered due to mechanical disturbances caused by the third explosion.

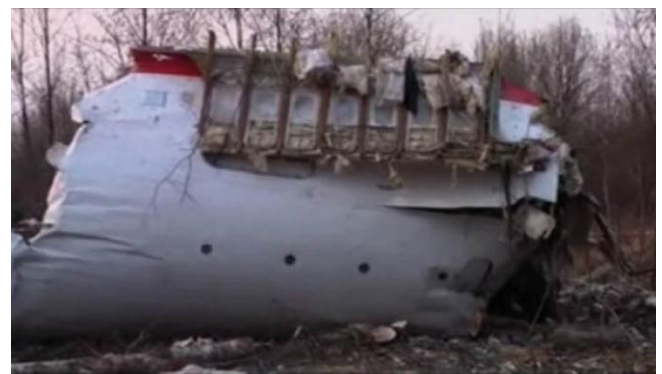
**Fig. 9.** The front bottom section below the president's salon. The entire top section is pulverized and the window section was thrown outwards most likely caused by the high internal pressure at the near ground explosion. Note the windows have not been in ground contact.

This indicates the tail structure was separated from the rest of the fuselage structure while the gyro moment was acting. The front bottom section below the president's salon is shown in Fig. 9. The entire top section is pulverized and missing. The window section was thrown outwards like caused by a high internal pressure at the near ground explosion. The windows show no sign of being in ground contact, which excludes the possibility of the top side of the fuselage being damaged and torn during the ground contact itself.

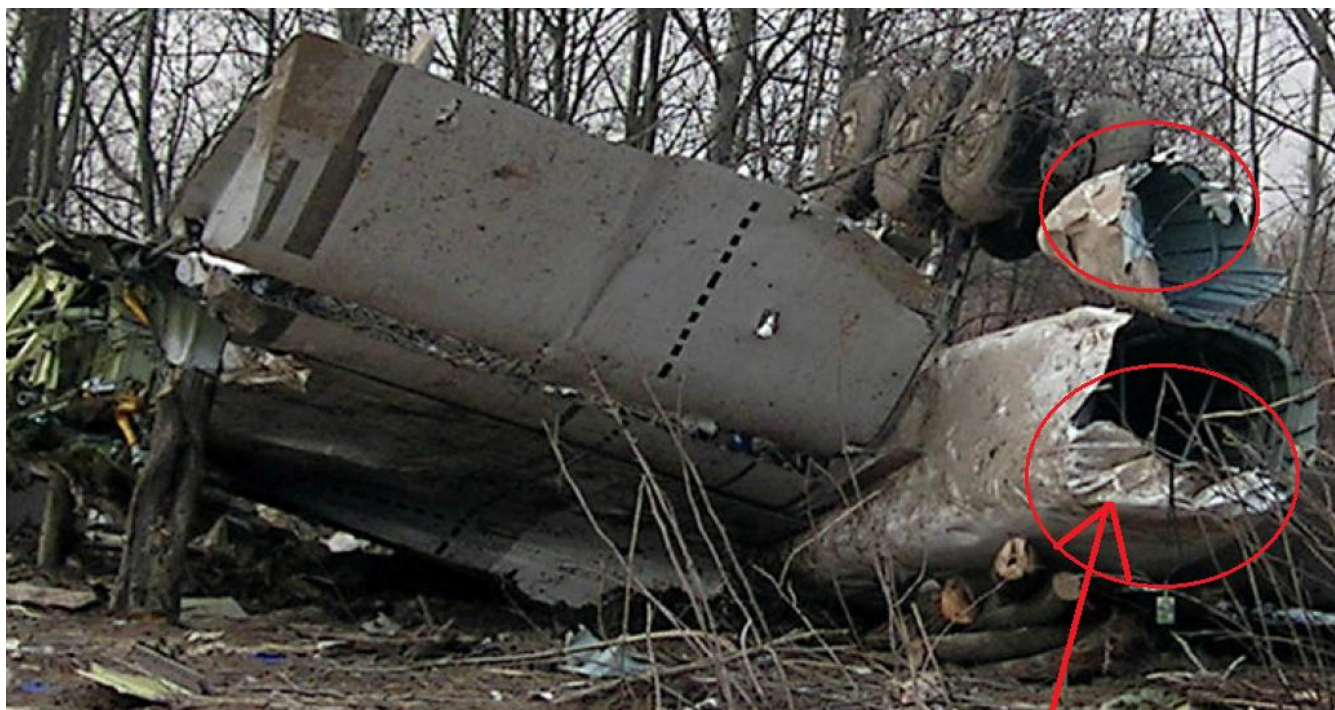
OBSTACLE HAS HIT FROM THIS SIDE

Fig. 10. The left wing root shortly after the crash. The portion shown in the pictures left side was originally facing towards the fuselage. Notice the wheels are soiled on the inwards side of both rows, but not along the entire rim, only at the small portion of the rim, that was facing downwards during the sideways sliding/turning movement of the wing piece. Also notice the end of the wheel house shows indication of being hit by an object (most likely a tree) from the wings topside during the roll movement described below.

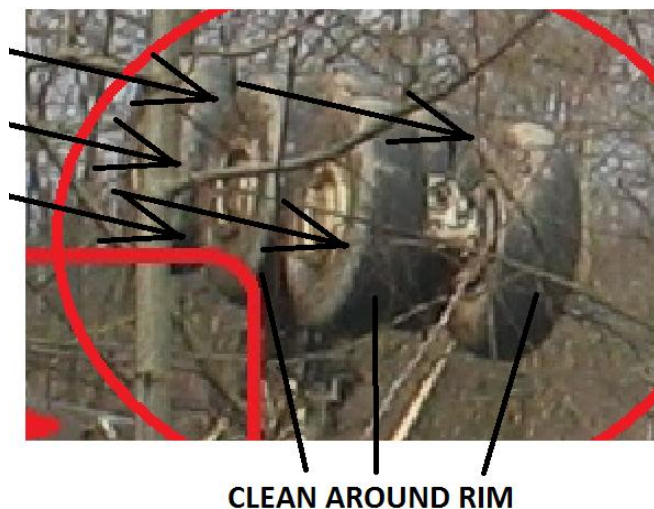
Fig. 11. The *inwards* side of the both rows of the left wheels is soiled, whereas the rims themselves are clean. Had the wheels been downwards in a normal landing position and making contact with the soft ground at the crash site, the rims should be covered with mud all around.

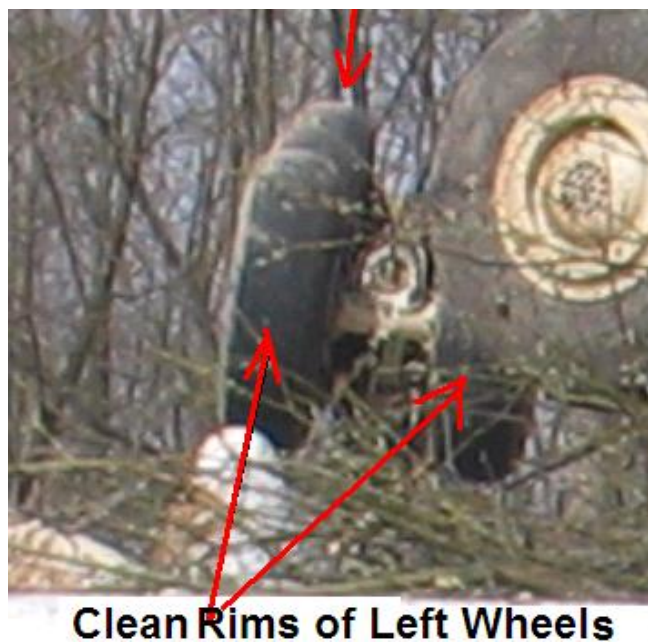
Fig. 12. Same as Fig. 11.

A high internal pressure is the most likely explanation for such outwards movement with this clockwise rotation (as seen from behind), because the turning moment arising from the downwards movement of the fuselage would result in an opposite rotation of this structure, due to the left wing tip making ground contact (see Fig. 17). The high internal pressure of the explosion changes the anti clockwise rotation of the wing root sending this outwards in a clockwise rotation (see Fig. 18).

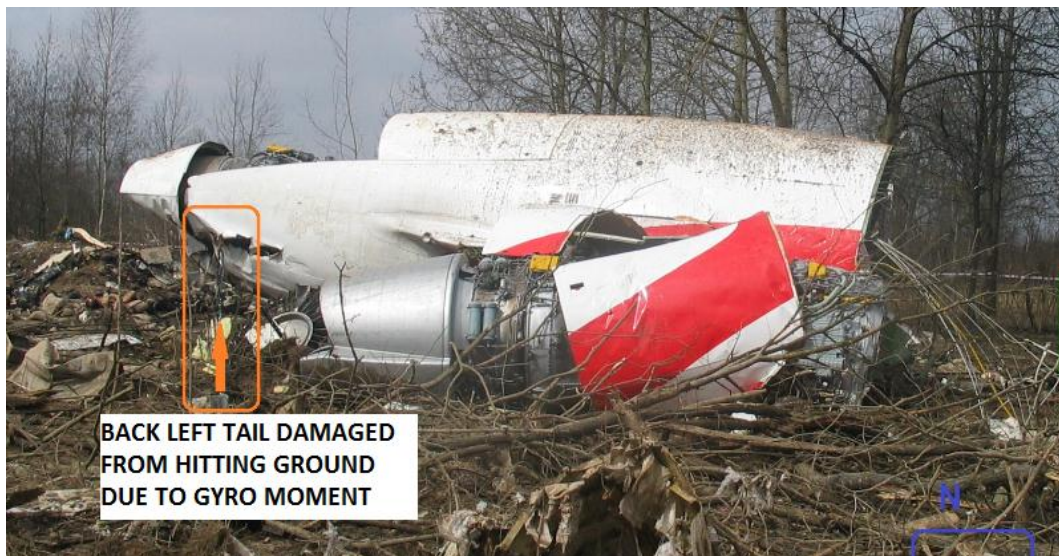
20). The inner structure of the tail shows clear sign of being bent by the gyro moment of the right motor (see Fig. 21).

Fig. 20. The back part of the tail was damaged by the centre motors gyro moment when the right motor broke off.

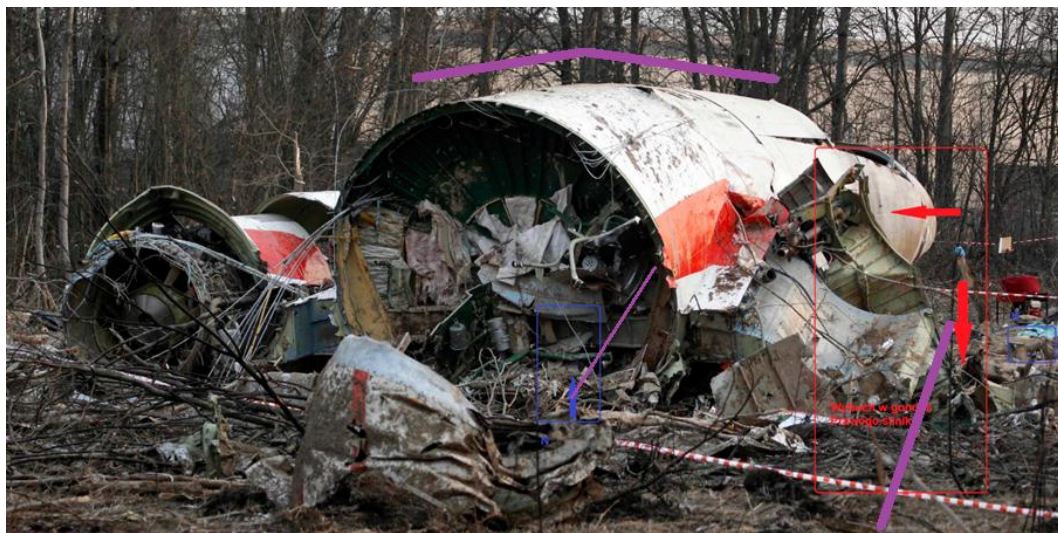
Fig. 21. The tail fuselage shows sign of the struggling between the gyro moments of the centre motor and right motor. Also notice the structure is twisted downwards inside the fuselage, indicating this structure was separated from the rest of the fuselage at the time of impact.

The twisted structure inside the tail fuselage indicates the tail was separated from the rest of the plane in air prior to the fuselage and left motor making ground contact.
