AN ENGINEERS VIEW ON HOW THE SMOLENSK CRASH COULD TAKE PLACE

Glenn Arthur Jørgensen

Abstract

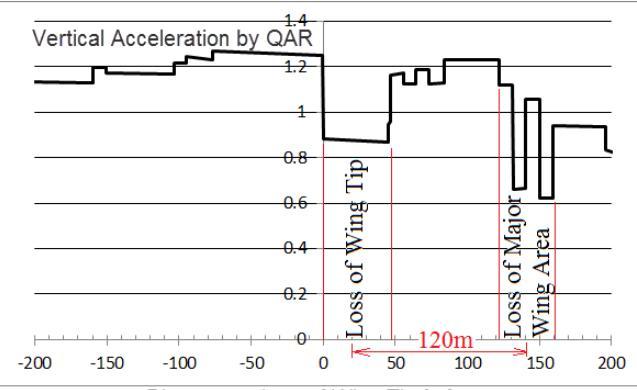
Fig. 1. The vertical acceleration data as logged by the Polish QAR black box. The distance flown by the plane between the loss of the wing tip and the loss of the major wing area is about 120m. Plane "flies" from left to right.

The black box data clearly show two distinct drops in the vertical acceleration sensor signal (see Fig. 1) with a distance of flight of about 120 m. A drop in the vertical acceleration is associated with a loss of lifting power of the wing. Following the second loss of wing area, the left rudder actuator shows an sudden and short erratic behavior for a short time not following the path of the right rudder actuator nor the commanded actuator signal. This can indicate, that parts from the left wing lost at this point colloid with the left tail section. When separating from the rest of the wing the wing fragments will tend to move upwards as a result of the aerodynamic force and explosive pressure forces acting on these. The tail of the TU-154M is a traditional "T" type, i.e.

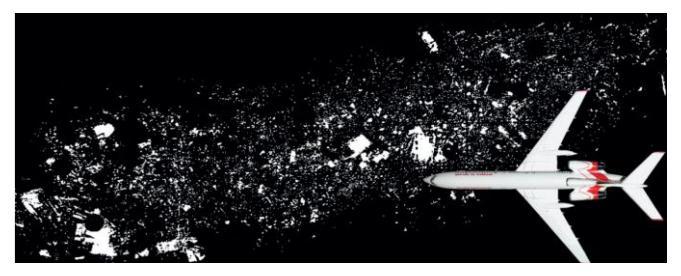
Fig. 2. A map of the debris found at the main crash site prepared for the Polish Archeologist report. The airplane in the bottom right corner shows the plane in the same scale [4].

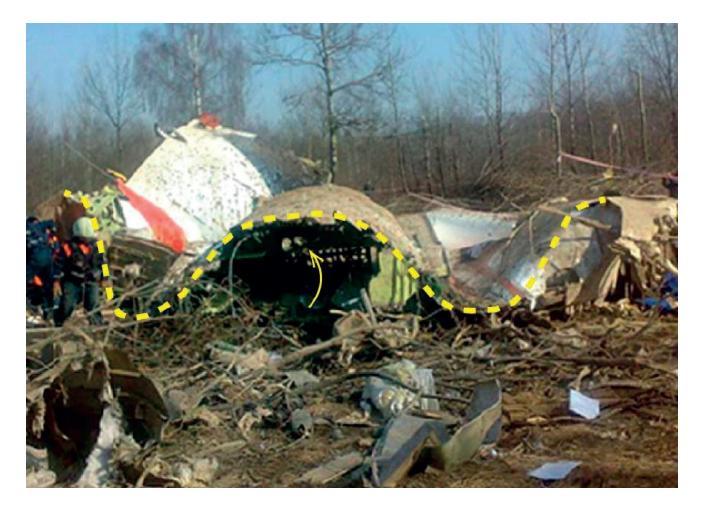
Fig. 5. Part of the inverted hull. It is clearly opened (yellow line and arrow) [4].

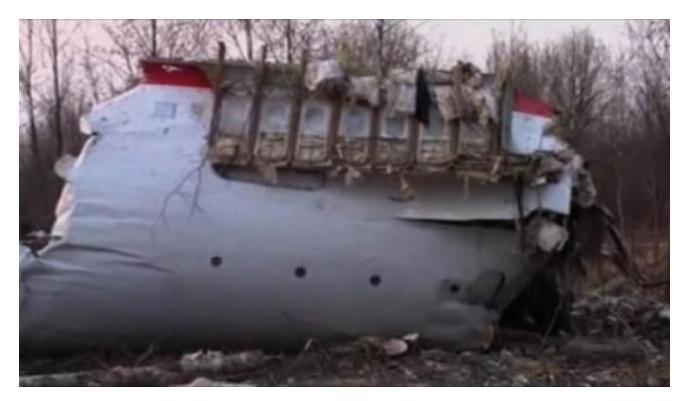
Fig. 6. The front bottom section below the president's salon. The entire top section is pulverized and the window section was thrown outwards most likely caused by the high internal pressure at the near ground explosion. Note the windows have not been in ground contact [7].

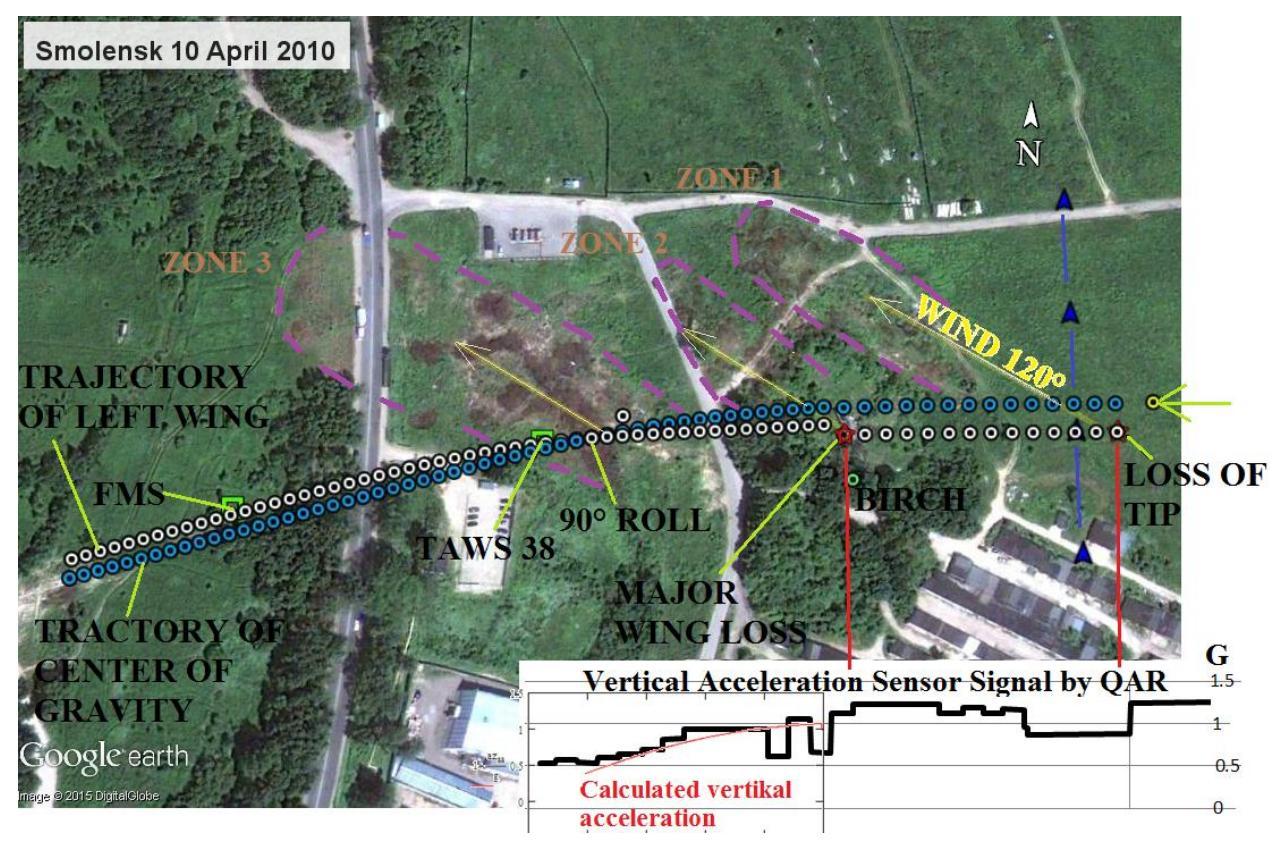
Fig. 7. The calculated trajectory for the center of gravity (blue) and the left wing tip (white). The satellite picture is from the 25th of June 2010 (two months after the crash). Notice the distinct and significant damage of vegetation in the three areas (zone 1, zone 2 and zone 3) circled by the dashed lines. Adding the recorded vertical acceleration signal by the Polish QAR (black line) and the wind direction of 120° show the clear correlation between the three distinct areas of vegetation damage to the approximate positions of 1. the loss of the wing tip, 2. loss of additional wing area and 3. the release of a large amount of fuel when the plane was rotated 90° most likely caused by a third explosion. This third explosion can together with the plane rotation explain why the TAWS38 event (landed) was initiated [7]. In agreement with the location of the damaged vegetation patterns the loss of the wing tip toke place 100m to 120 m earlier than the birch tree. The distance between the patterns corresponds to the flying distance

between the two events (loss of wing lift) as recorded by the Polish QAR black box. The final calculated velocity (Vz=23 m/s) towards the ground at the "FMS" point agrees with the recorded value of Vz=22.2 m/s. The scenario can also explain why wing parts are found earlier than the birch tree. The calculated vertical acceleration (red line of bottom fig) shows same characteristic decline as the recorded signal.

Signs of vegetation damage are observated in three distinct areas located 120 m apart at positions where fuel spillage from the left wing are expected to occur with a wind direction of about 120° (see Fig. 7). The two first locations are in good agreement with the hypothesis of two wing explosions, the first cutting the wing tip and the second 120m further downstream removing the central part of the wing. The third zone much larger and intense than the two

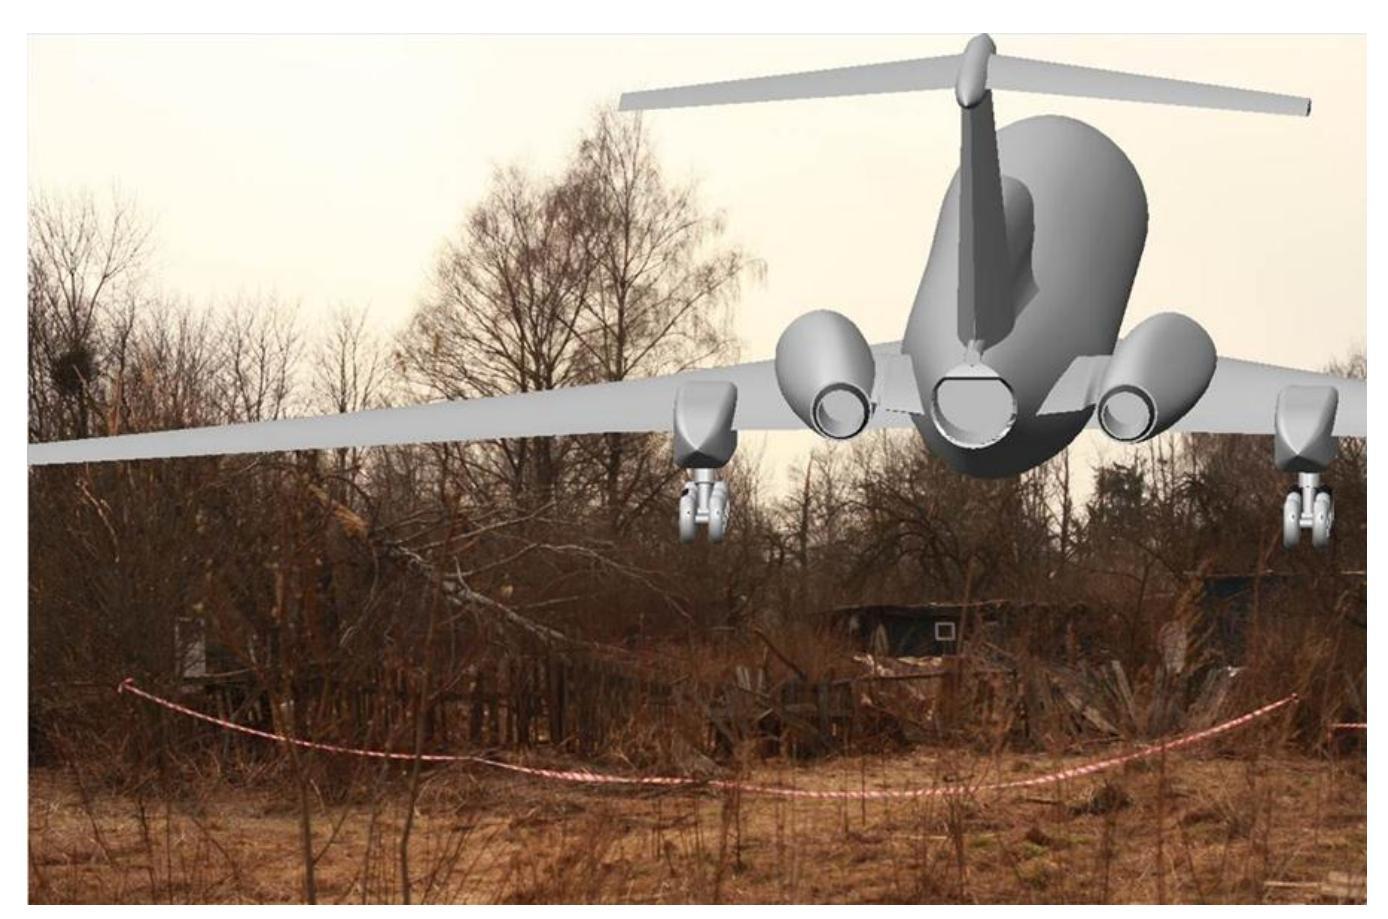
Fig. 8. According to the official explanation the plane flew at this height with an inclination of 15° to 20° when the left wing hit the birch tree (the now broken one in the left part of this picture) in 5m height above the ground. Note the fence and shacks will by this story be in the direct line of fire of the planes thrust power.

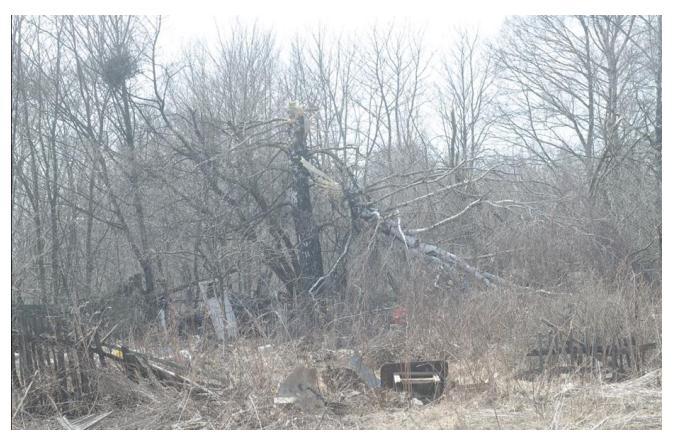
Fig. 10. The Russians claim this is what happened to the fence, which in that case has proven to be unbelievable strong.

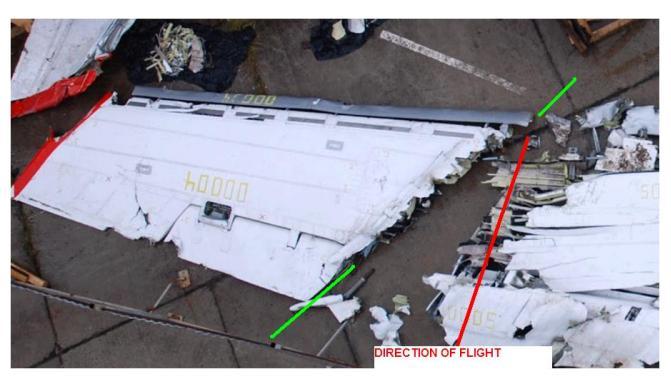
Fig. 21. The wing tip from P101 is cut along the line going from the natural division between the slats (point C) to the edge of the aileron. The crash engineer would warn that no good explanation can be given to the public for this issue.

The line of cut of the wing tip is located at the only possible position for a pre-loading with explosives as described in chapter 3.7 and forms the predicted 20° angle and location with the direction of flight. No official explanation exsists for this large 20° discrepancy.

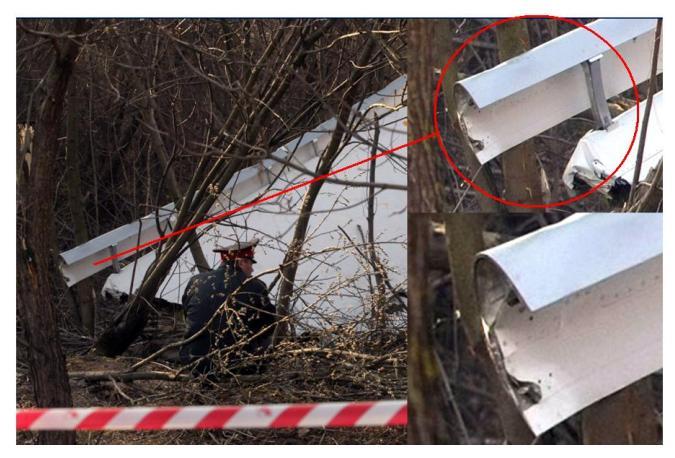
Fig. 22. The slat edge is clearly out of line with the line of cut. This is an unavoidable problem. The crash engineer would warn that no good explanation can be given to the public for this issue .

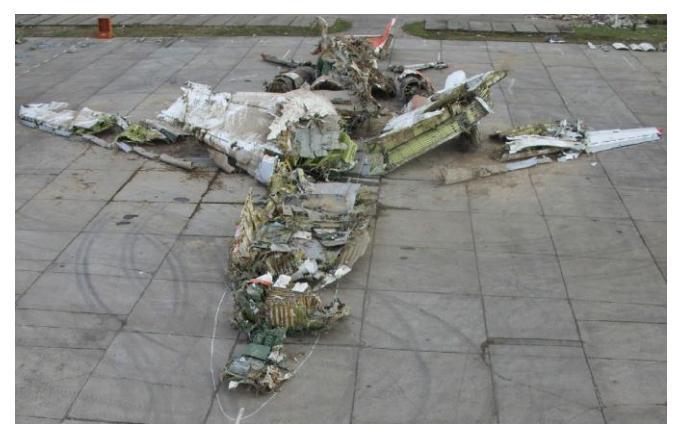
Fig. 24. The left and right wings show great similarity. Both are divided into: wing tip, center section in small pieces and the wing root. According to the official explanation the right wing was in free air all the time, and the left wing supposedly hit first a birch tree and later ploughed into the ground. The expected wing destruction should therefore be very different for the two sides left and right.

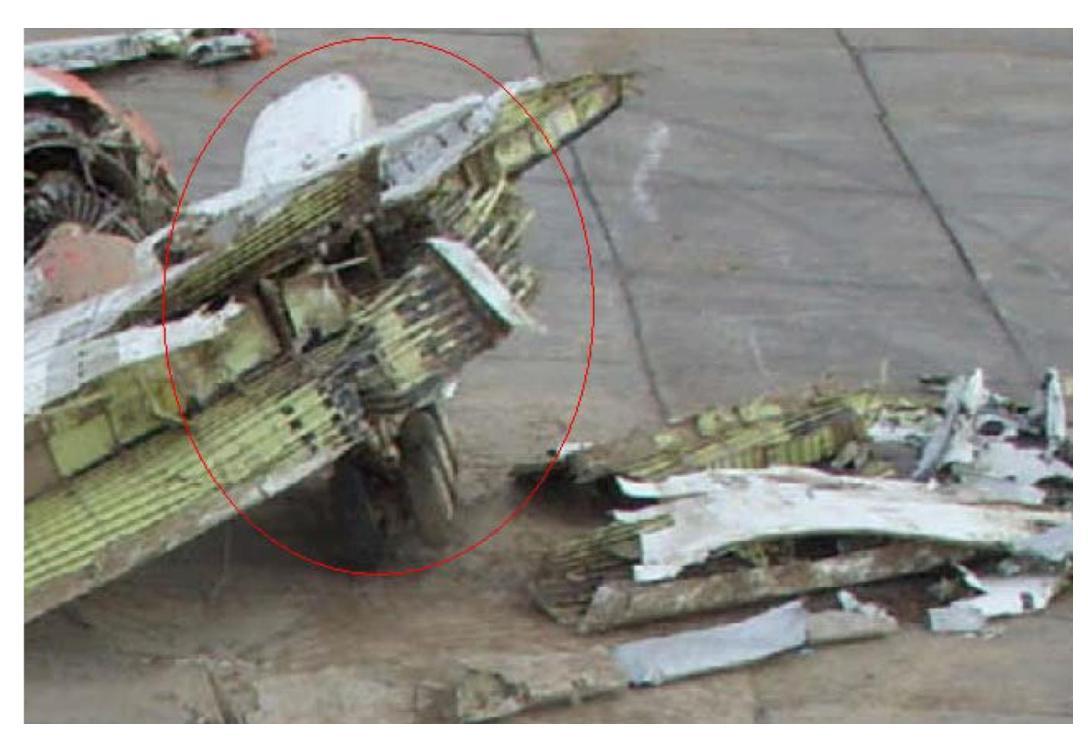
In the left inner flap is found to be in a position of 28° whereas the right flap is in a position of 36° [22]. Assuming it very unlikely that such difference exists during normal flight, this points towards a manipulation of the flaps after the flight ended. The self-locking spindle system excludes this happening during the crash itself. This could point towards the change occuring after the crash. The damage of the left spindle that was present after the crash makes it unlikely that this side could be manipulated. The conclusion of this that the flaps most likely were in a position of 28° prior to the wing loss, and therefore configured by the pilots for the go-around (flaps setting 28° for go-around) rather than for a landing (flaps setting is 36° for landing). Fig. 27 show the plane as it makes the first ground contact. The edge of the shortened left wing is expected to be bent backwards, and this can be observated in Fig. 28. Also the signs of ground contact and the parts with no sign of ground contact shown in Fig. 28 agree with the hypothesis of a wing loss of about 10 m wing.

Fig. 28. The edge of the left wing root is bent backwards and shows clear sign of ground contact, so does the inner part of the slat, where the nabourgh part of the slat shows no sign of ground contact. The bottom part of the middle section of the wing shows sign of ground contact, where the top part broken in fine sharp edged debris characteristic by explosion like described in Fig. 27. These observations agree with the hypothesis of wing loss by two explosions put forward in [2] and [7].
