# MAJOR ERRORS OF THE OFFICIAL RUSSIAN AND POLISH INVESTIGATIONS OF THE SMOLENSK CRASH

Glenn Arthur Jørgensen

#### Abstract

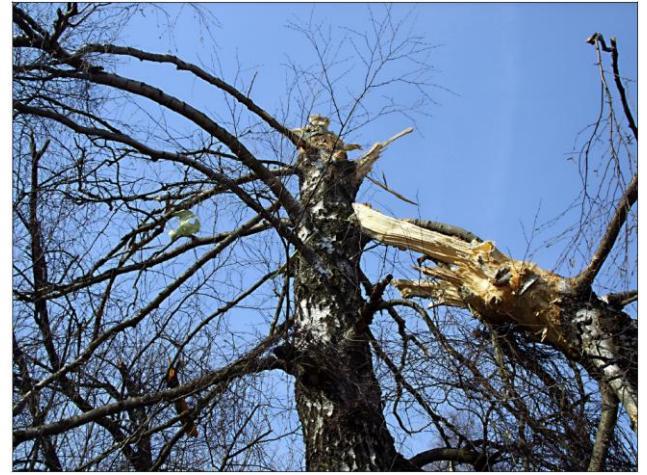
Figure 2. Photo of the birch tree claimed by the Russians to have cut through the wing, Note the loosely hanging wing fragment to the left.

An analysis of satellite photos published in the journal "Mathematical and Computational Forestry & Natural Resources Sciences" shows, that the birch tree was broken already at least five days before the crash<sup>7</sup>.

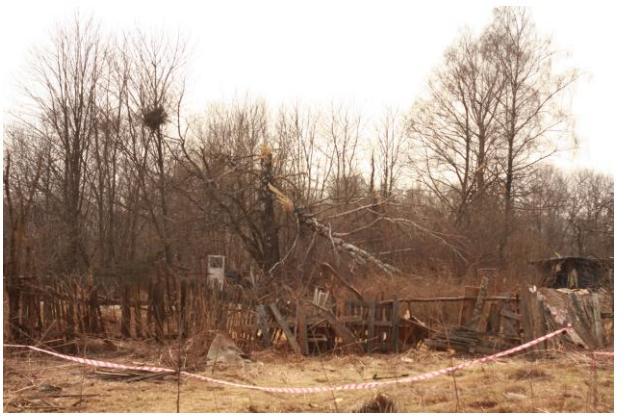
Figure 3 The fence and surroundings showed no sign of an 80 ton plane flying 5m above the ground with its three tail engines bursting at full speed.

An 80 ton TU-154M jet plane with its engines at take-off power and passing at 75m/s will send a pressure against its surroundings<sup>8</sup> - including an old ramshackle wooden fence - in the order of 15-20 tons for a duration of more than 0.5s. Calculations show, that the pieces of wooden fence near the claimed birch tree, would be accelerated within the first 0.1s to a velocity of more than 16m/s and be shattered in the downstream direction. The main part of the fence is standing as nothing happened.

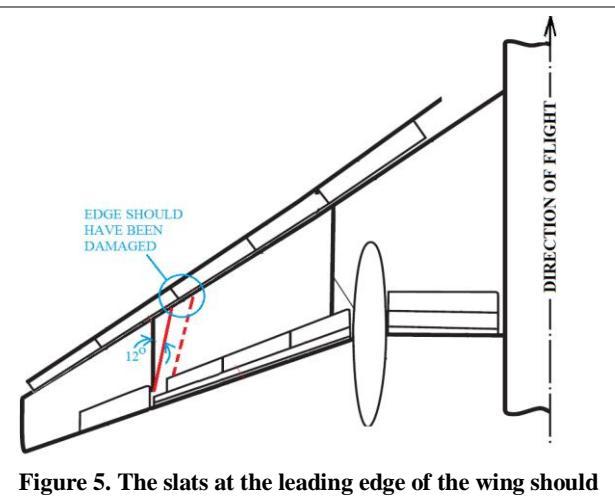
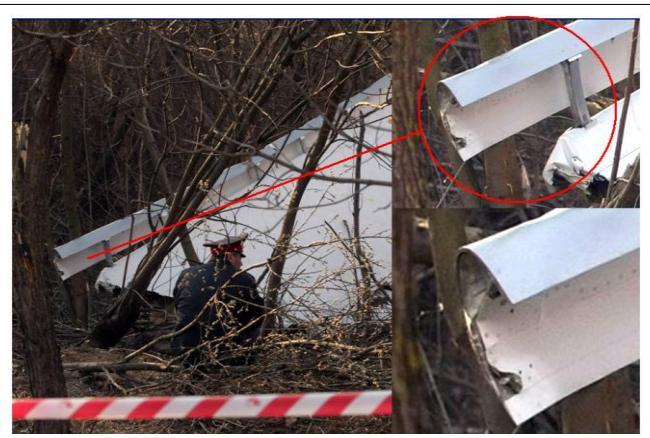
have been damaged and the line of cut should have been in the direction of flight if the birch tree cut the wing. This was not the case. Earlier an angle of  $20^{\circ}$  was found, but when taking the slats extension into account this is closer to  $12^{\circ}$ .

Figure 4. The front edge of the slat in the line of the birch tree was completely undamaged.

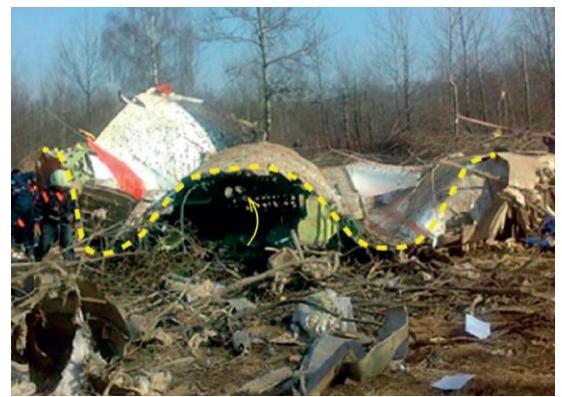
Figure 7. Sandia National Laboratories have independently of Prof. Binienda's group proved, that only by an explosion in the fuselage in the air can the fuselage end in such open shape as seen in Smolensk.

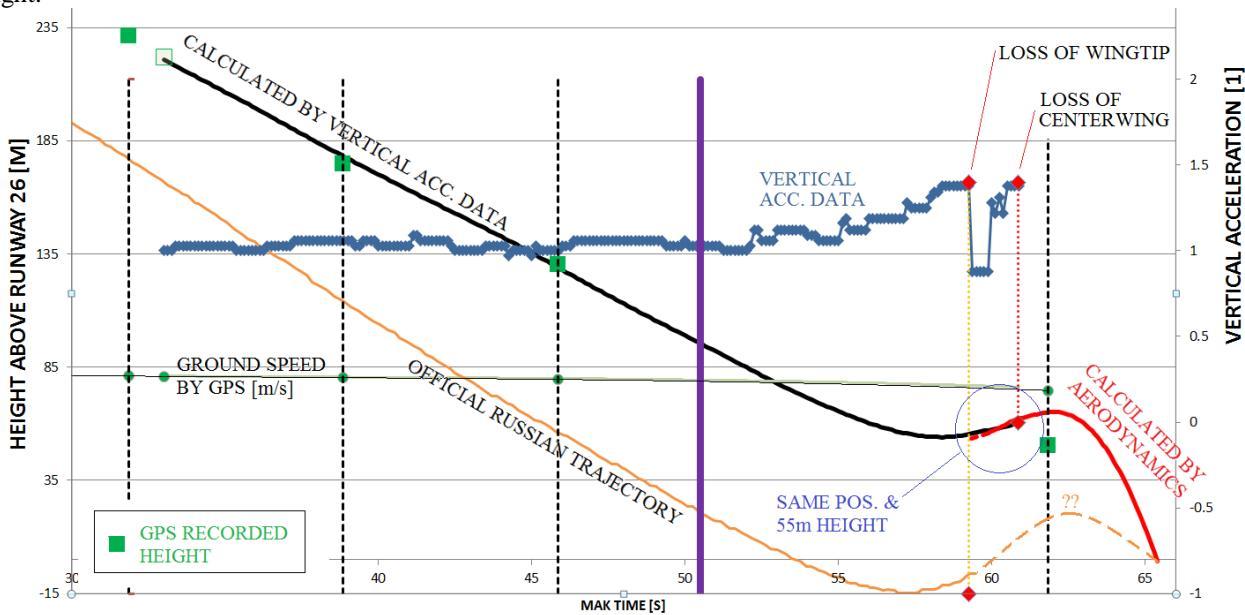
Figure 8. Two totally different methods based on two independent sets of data both result within about 10m the same position of the plane 55m±10m above the runway altitude, when it lost the first part of its left wing. The plane was in free air space where no obstacles exist when losing wing area. The calculated trajectories agree with the recorded GPS positions and a long list of other field data recorded by the black boxes.

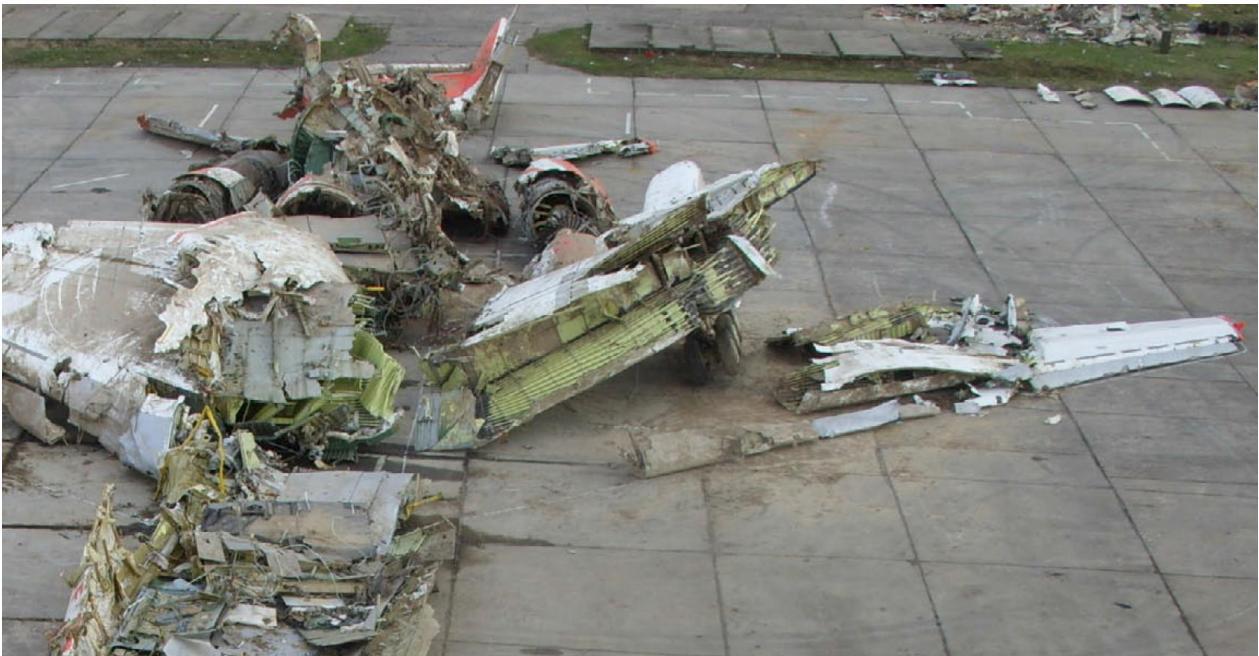
This work is confirmed further by the vertical acceleration sensor data after the loss of the wing tip. The sensor clearly shows first a loss of lift capacity (of about 7%) followed by another even bigger loss of lift capacity 120m down the line<sup>19</sup>. The first lift loss is explained by the Russians as a result of hitting the birch tree. The Russians gave no explanation to the second loss of lift.

Figure 9 The left wing was found in three sections. The outmost 5.5m part (wing tip) was found in one piece. The next about 4.5m section was found in many tiny irregular and sharp edged fragments. The inner section was broken, where the wing is strongest. Note the inner front slat shows sign of ground contact, the middle slat portion not, this does not agree with the official explanation.

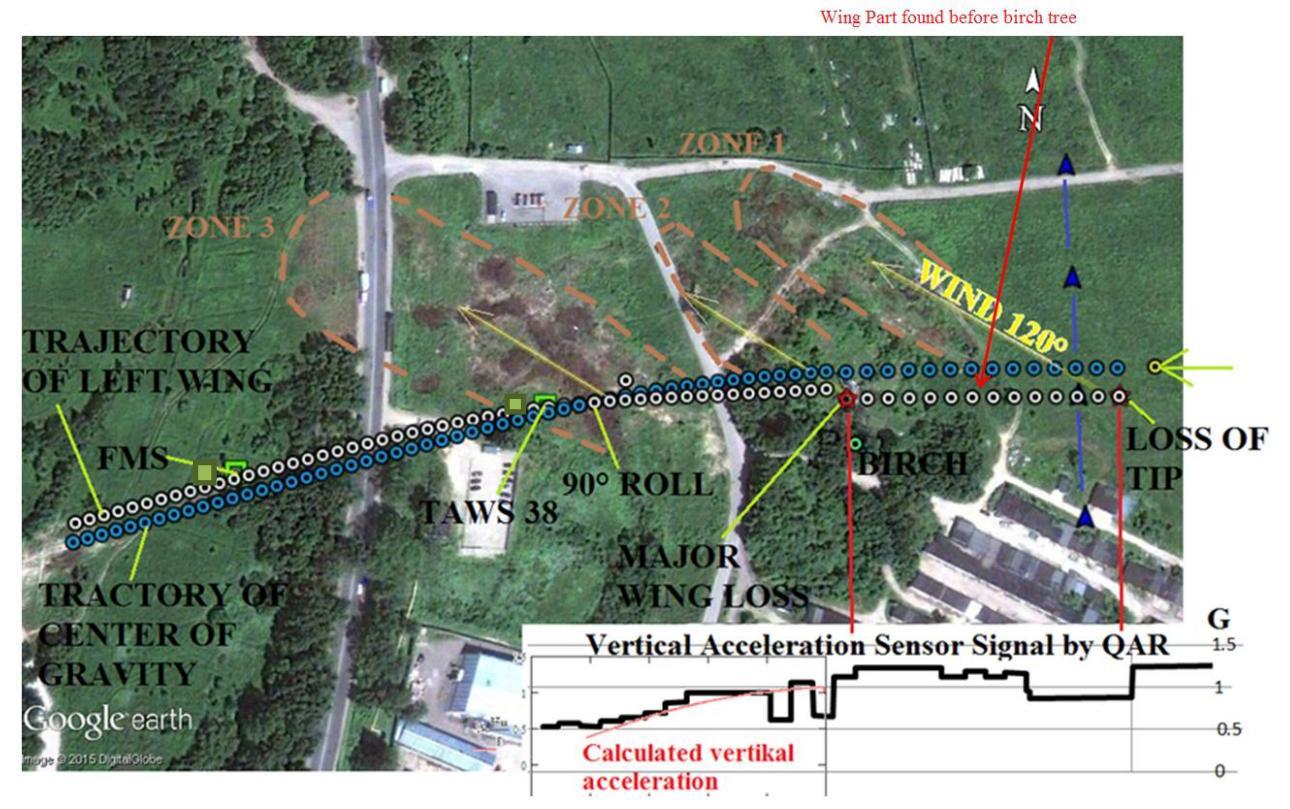
Downstream in the direction of the wind (120deg) the vegetation is damaged as poisoned by the fuel in three distinct zones starting at the calculated points of the two wing losses and the third and hardest damaged zone at the point where the plane was rotated 90deg, this zone most likely from the dumping of the central fuel tanks by a third directional type explosion. This can explain why the landing sensor falsely indicated the plane had landed at this position in 55m height as measured by the GPS<sup>20</sup>.

Figure 10. Three distinct zones of damaged vegetation can be found 2 months after the crash downwind to the calculated positions of wing loss indicating the damaged zones are caused by poisoning of jet fuel and hydraulic oil, when the wing sections were damaged. Calculations show this toke place in 45m-55m height above the runway in free airspace where no obstacles exist. Wing part was found prior to the tree the Russians claimed to cause the damage to the wing. Blue curve shows calculated trajectory of the plane's center of gravity, the white curve shows the calculated trajectory of the left wing tip. The green squares are black box recorded GPS positions.

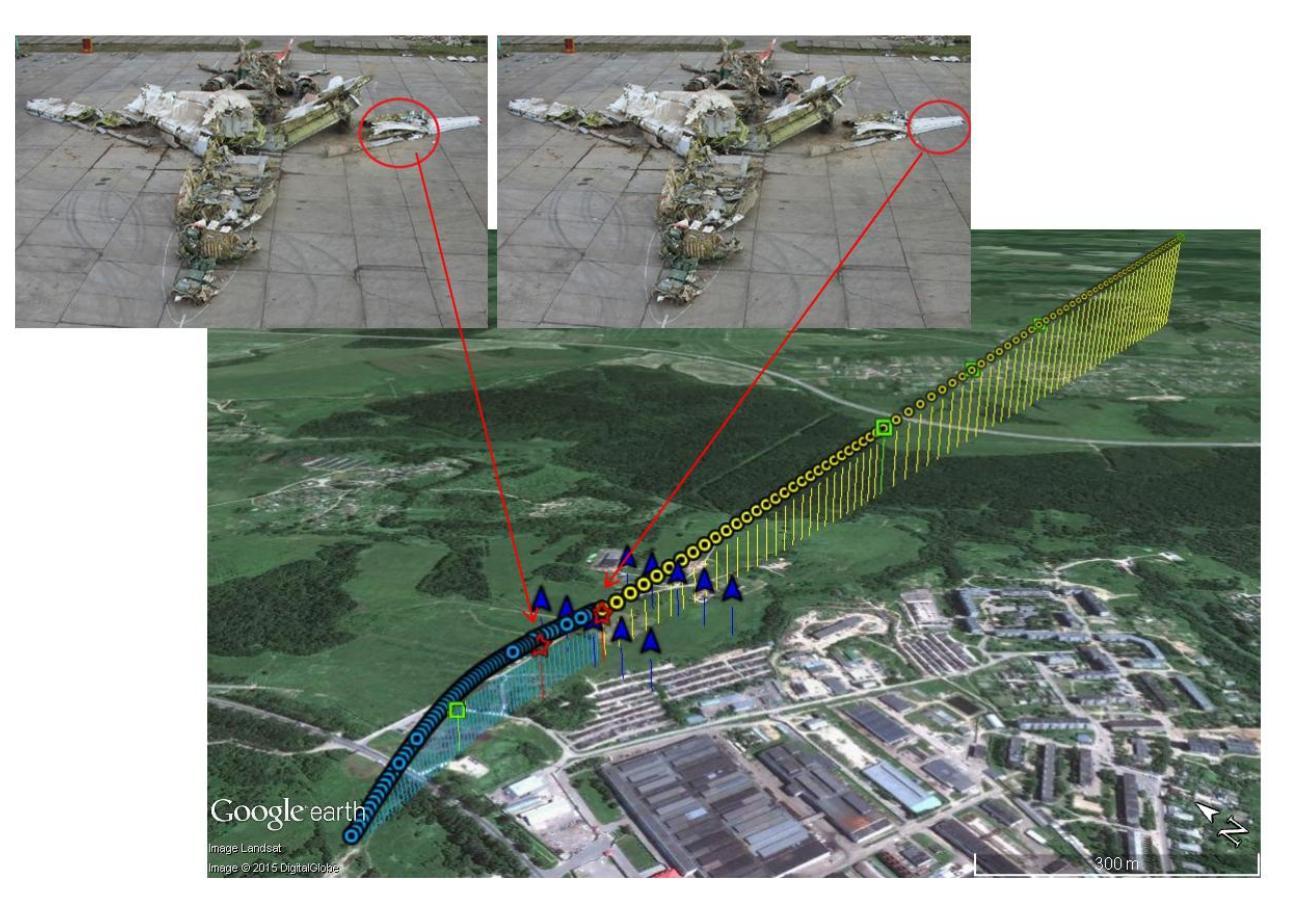
Figure 11. The green squares are recorded GPS positions of the plane during descend. The blue triangles show the middle marker zone. According to black box data the wing tip was lost at the right most red marker 55m height above the runway, followed by the center section 120m closer to the crash site. The calculated trajectories of both the fuselage and wing tip end at the correct positions and with correct heading at the crash site, and the final calculated vertical speed matches the recorded value within 5%. The positions of wing losses correlate well with the zones of damaged vegetation as seen two months later during the following summer season.
