# THE LAST SECONDS OF FLIGHT OF THE TU-154M IN SMOLENSK ON 10<sup>TH</sup> OF APRIL 2010

Glenn Arthur Jørgensen

## Abstract

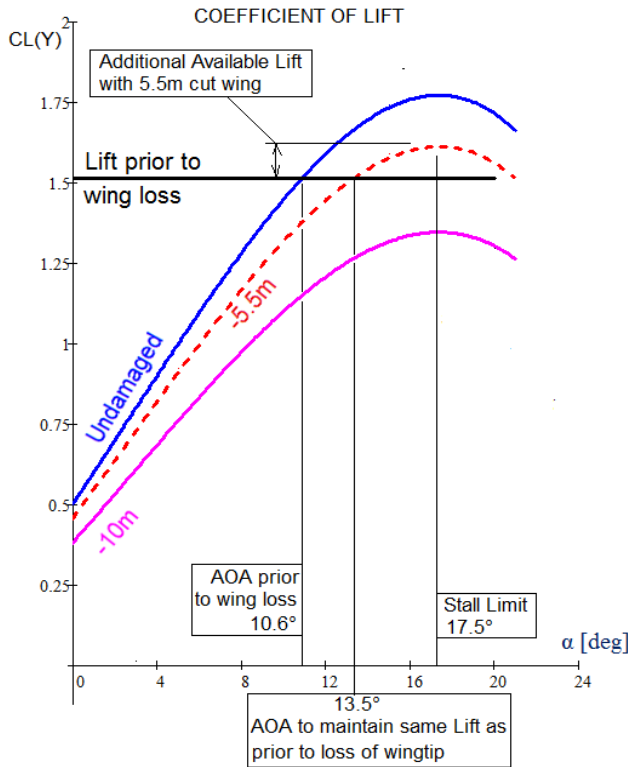
**Fig. 1.** The overall lifting coefficient  $Cl$  versus the angle of attack for the undamaged wing (blue solid line), a wing with a loss of  $\Delta L = 5.5 \text{ m}$  (red dashed line) and a wing with loss of  $\Delta L = 10 \text{ m}$  (magenta solid line).

By Fig. 1 it is seen, that a lifting coefficient of  $Cl = 1.516$  is obtained for  $\alpha = 10.6^\circ$  for the undamaged wing and for  $\alpha = 13.5^\circ$  for the case of a loss of a wing span of  $\Delta L = 5.5 \text{ m}$ .

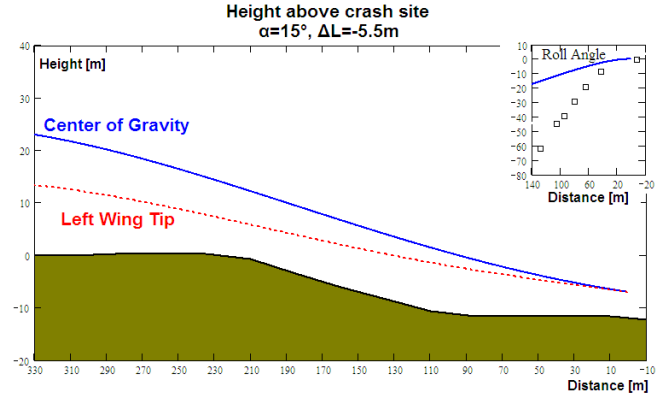
**Fig. 2.** The calculated trajectory of the planes center of gravity (blue line) and left wing tip (red dotted line) for the case of a wing loss of  $\Delta L = 5.5 \text{ m}$  at  $5 \text{ m}$  height above the ground of the birch tree as assumed by the official Russian story. Here with the use of the right aileron/outer interceptor. The effect of the immediate vertical velocity change of  $\Delta Vz = -2 \text{ m/s}$  as found in equation (6) is included. The plane is flying from right to left. The green area represents the ground height as by [5]. The small inserted box shows the resulting roll angle of the plane (blue line) together with the recorded roll angle (black squares). Note the plane would roll moderately and climb well above the crash site with a loss of the wing tip only. Note the roll angle of the plane after  $140 \text{ m}$  flight (see inserted box in upper right corner) corresponds well with the recorded plane roll by the QAR black box (roll =  $17^\circ$ ) as shown in Fig. 3.

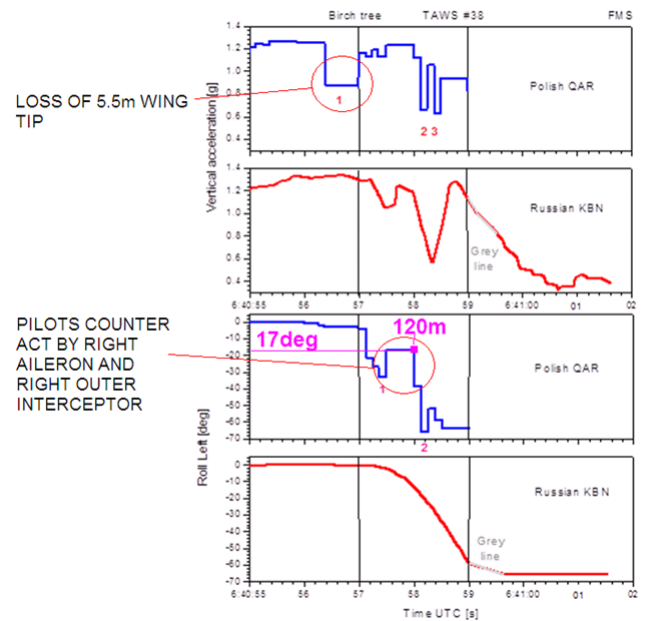
**Fig. 3.** From the top is shown the vertical acceleration by the Polish QAR, then the same by the Russian KBN. Next two plots show the left roll angle by the Polish QAR then the same by the Russian KBN. Event 1 corresponds to the loss of the wing tip and event (2, 3) the loss of the additional effective  $4.5 \text{ m}$  of the left wing. The distance from first drop in the vertical acceleration signal to the second event is approximately  $120 \text{ m}$

by the QAR data and about 47m by the Russian KBN data. The roll of the plane 120m after loosing the wing tip can be seen as  $\phi = -17^\circ$  by the black box data. This agrees well with the calculated value shown in fig. 2 Original figure by Prof. Kazimierz Nowaczyk.

where  $\Delta G_1$  is the sudden drop in vertical acceleration, and  $\Delta T$  the time this occurs. For a drop of say  $\Delta G_1 = 0.367$  over at time say  $\Delta T_1 = 0.6$  s (see Fig. 3) one gets

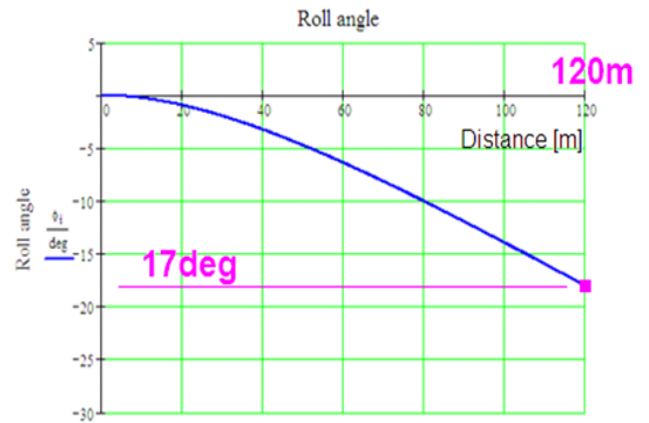
Fig. 4. The calculated roll angle as a function of distance in the event the reaction time of  $\Delta T = 0.3$  s to achieve the full right aileron and full right outer interceptor between the two wing losses. This takes into account the human reaction time and the system latency. The roll angle in this case is found to be  $\phi = -17^\circ$  at a distance 120 m from the loss of the wing tip. This corresponds very well with the value recorded by the QAR black box as shown in Fig. 3.

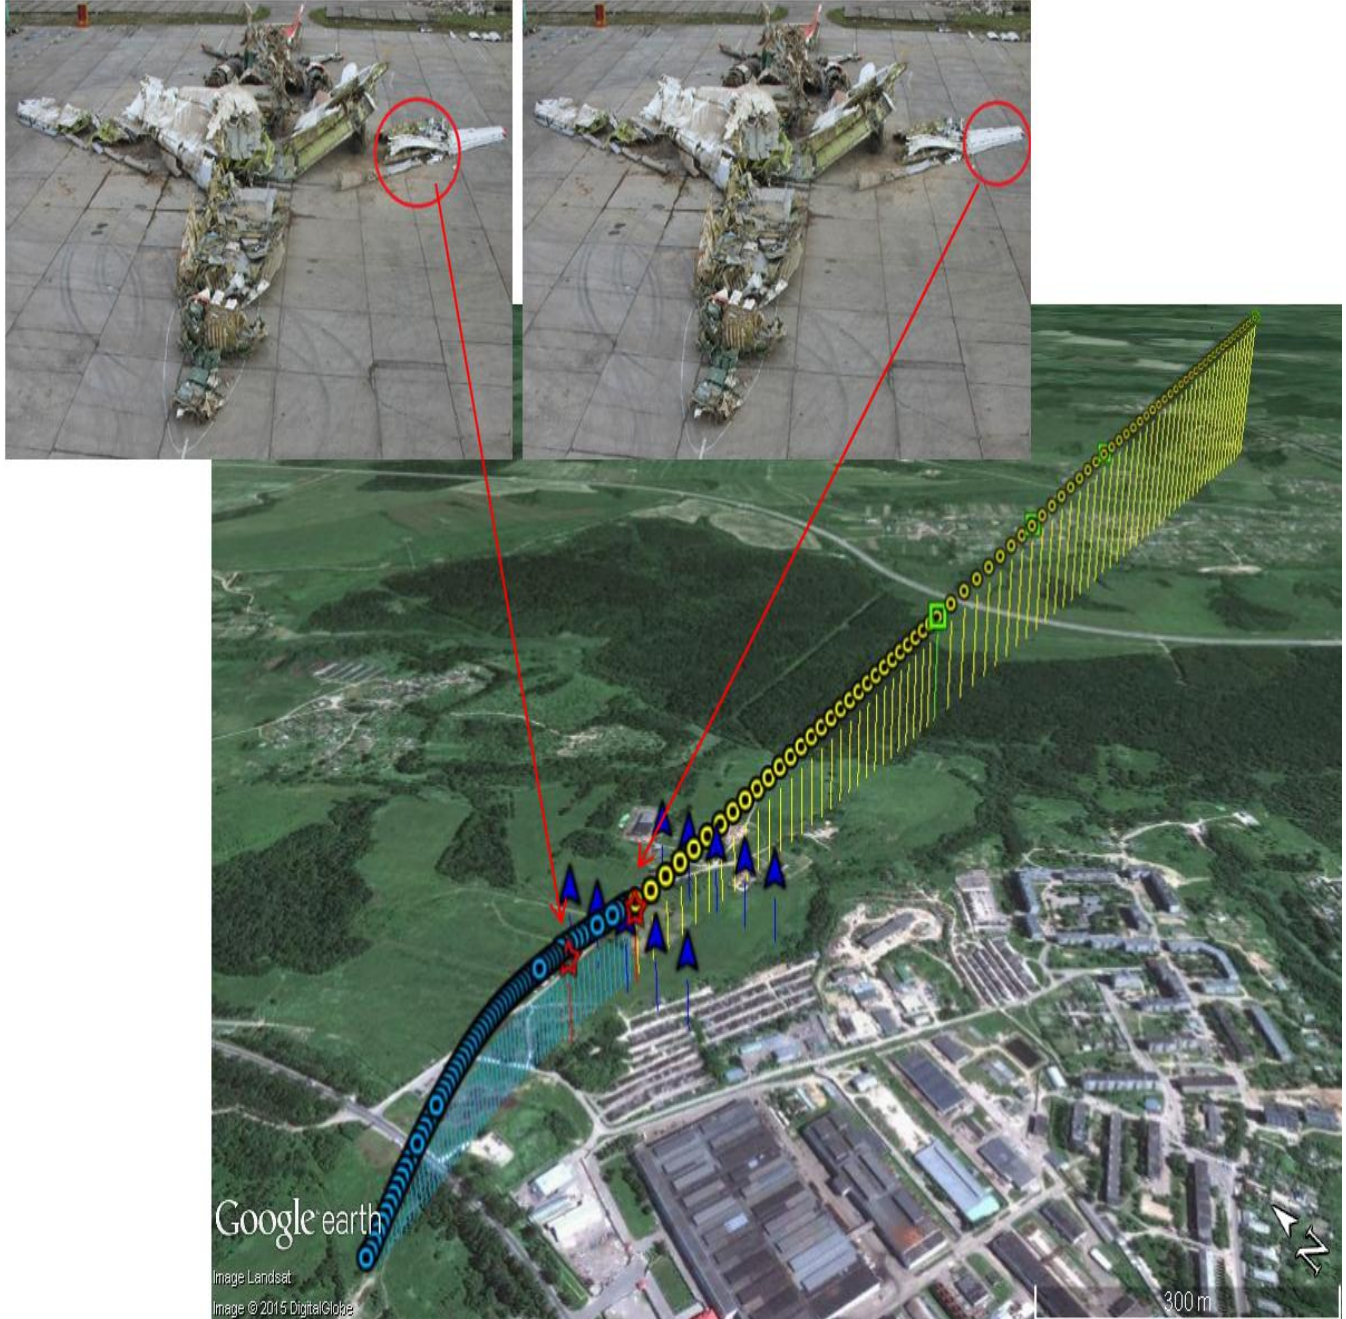
Fig. 5. The green squares show the logged GPS heights [9, 10] and positions of the TAWS 34 to TAWS 37 events [9, 10], and the yellow dots show the trajectory line between these together with the trajectory of go-around within the middle marker zone (blue triangles). Working back from the crash site by the aerodynamics brings the trajectory of the center of gravity (blue circles) to the exact position of the GPS trajectory. According to the official Russian explanation the pilots called they would do "go-around" at  $T=10:40:50.5$ . The calculated height above runway 26 at this point is  $H=95\text{m}$  to  $H=100\text{m}$ . This confirms the calculations, as  $H=100\text{m}$  is the official decision height during this approach. With other words this is the lowest height, where the pilots must make their decision to either continue the approach or perform a go-around depending on whether they have correct visual sight of the runway or not. By the official explanation it is known, that the pilots did not have the required visual sight of the runway, and it is therefore a logic consequence of this, that they called the go-around at this height. The data and calculations clearly support this. The red stars show the two positions where the wing explosions occurred, and the upper figures show which wing sections are lost. The second explosion mainly removes the top part of the middle wing section by creating a center hole. During the remaining flight this part of the wing continues to break up as a result of the aerodynamic forces. The bottom part of the middle section with the Polish emblem is most likely torn off during the first wing ground contact. Following the two wing explosions a third explosion

emptying the center fuel tanks took place at the position of the TAWS 38, and was probably the cause of the false interpretation by the control system that the plane had landed.

Fig. 5 shows how the calculated trajectory based on the aero dynamics and the CFD input perfectly meet the trajectory made by a line passing through the recorded GPS heights and positions including a go-around manuvre as recorded by the vertical acceleration sensor. Also the calculated vertical speed towards the ground is in agreement with the recorded 22.2 m/s at the position of the final FMS recording 60 m before the point of wing ground contact. With other words *the pilots never made the very strange steep dive to the ground 2-3 km before runway 26 as claimed by the Russians*. They did not approach terrain with 23 m/s when at 65 m above the ground as stated in the MAK report. Such dive makes no sense what so ever, even

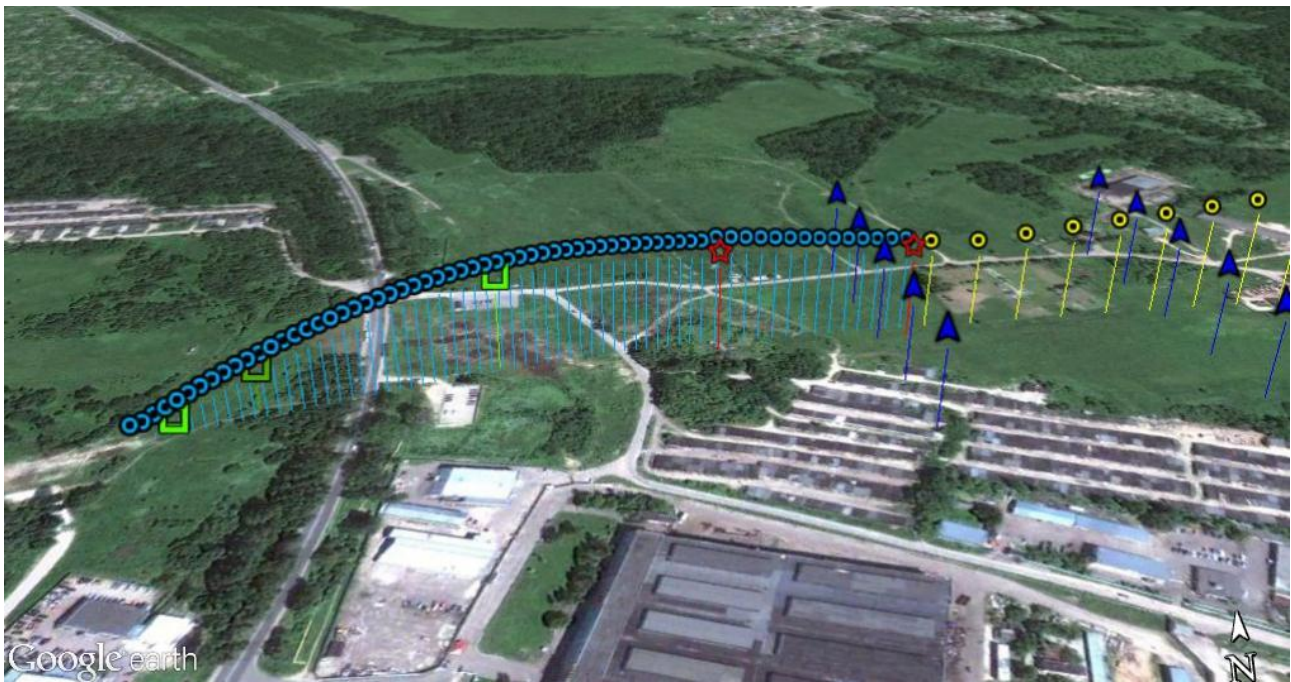
Fig. 6. The loss of the wing tip occurs during pulling up in the go-around just prior to exiting the middle marker zone shown between the blue triangles at a height of about 55 m. The height entering the middle marker zone is about 75 m. The calculated trajectory of the center of gravity of the plane agrees reasonably with the logged GPS height of the TAWS 38 (the calculated height is slightly higher than the logged) and fits well with the baro corrected height and GPS position stored by the FMS (green squares). The velocity towards the ground at this point is recorded as  $V_z=22.2$  m/s and agrees very well with the calculated  $V_z=23$  m/s.

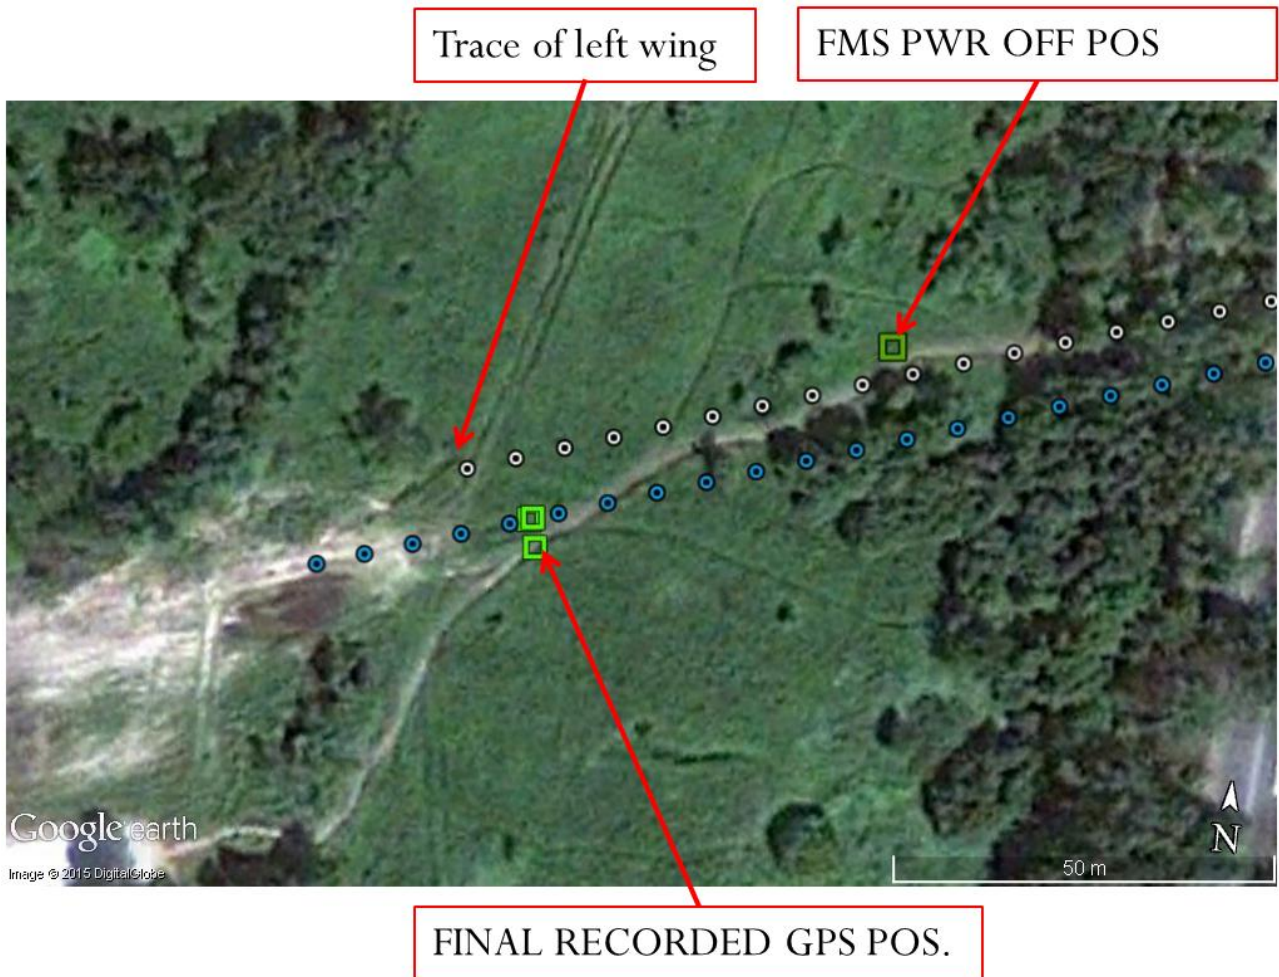
Fig. 7. The calculated trajectory of the center of gravity (COG) of the plane (blue circles) and the calculated trajectory of the left wing (white circles). Note how the wing trajectory ends at the position of the wing ground trace, and how the COG trajectory ends at the correct location passing through the final recorded three independent GPS positions. Note also how the heading is in well agreement with the direction of the ground scratches.

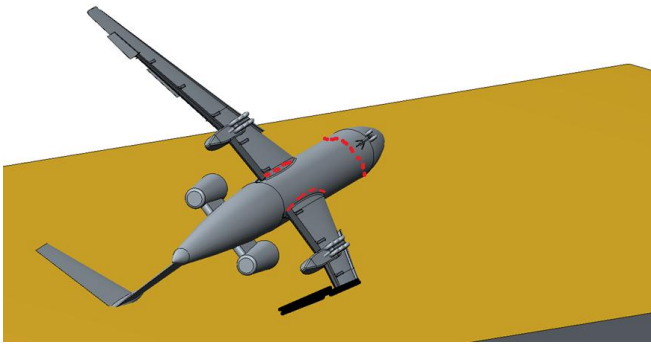
Fig. 13. The plane making its first ground contact with the left wing tip and tail. The planes orientation is found both by the aero dynamical work and independently confirmed by the ground trace analysis [3]. As the left wing tip is in contact with the ground the downwards movement of the fuselage will result in an anti clockwise rotation of the left root part.

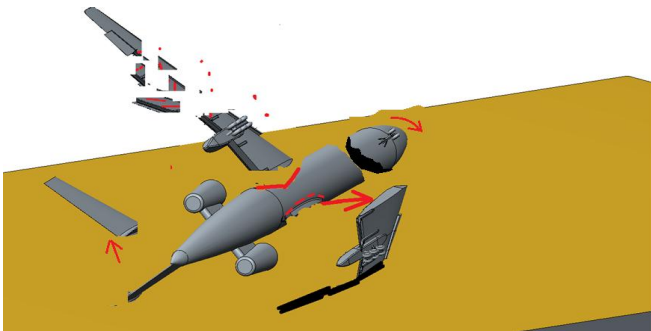
Fig. 14. Based on the length of the ground trace the first main fuselage explosion occurred 0.3 s after the initial ground contact. From this point all ground traces suddenly stop, and no crater is formed even though the official explanation states the 78.6 tonne plane hit the soft ground with more than 100 g, equal to 78600 tonne [5].

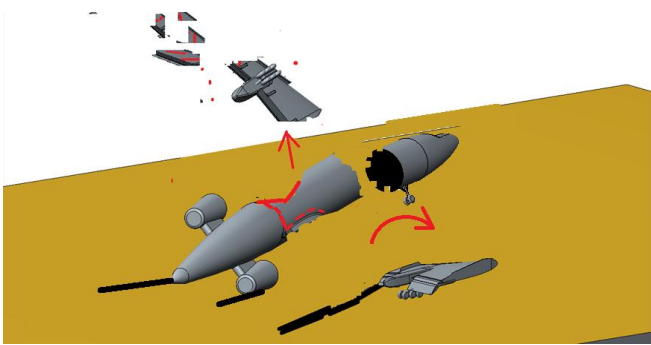
Fig. 15. When the wheels hit the ground and continued the outwards sliding movement superimposed on the initial forward velocity of the plane, the inner sides of the wheels scrapped against the ground and were soiled on this side and the inner rim portion that was downward during the slide.

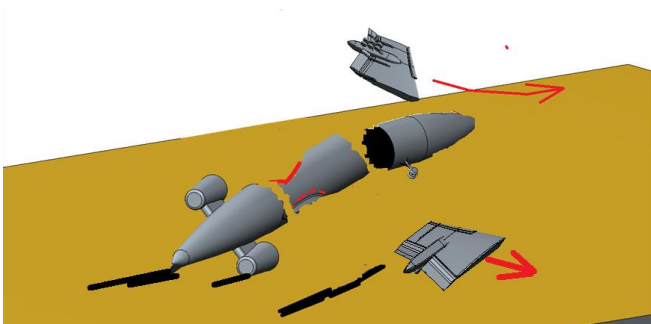
Fig. 16. The root part continues its sideways movement and rotation.

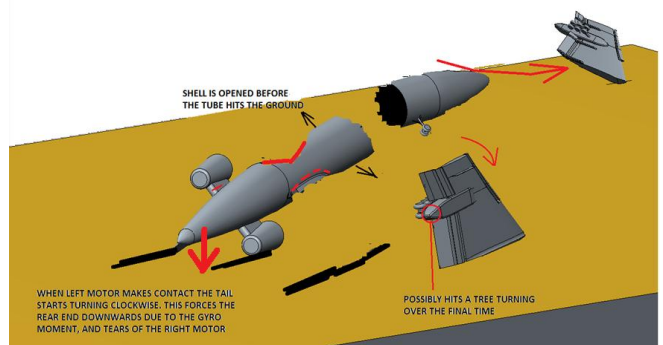
Fig. 17. During the rotation the left wheel house hits an obstacle (probably a tree) and damages the wheel house tip partly cutting this. Note the fuselage is still in free air when the explosion occurs, allowing this to open and the sides to be move outwards prior to it hitting the ground.

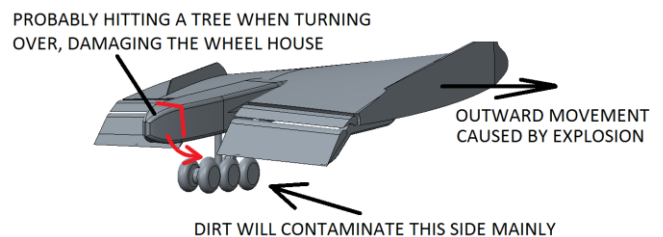
Fig. 18. The outwards sliding movement caused by the fuselage explosion will tend to contaminate the inner sides of the left wheels and the portion of the wheel rims facing downwards. The wheels show no sign of rotation during this movement.

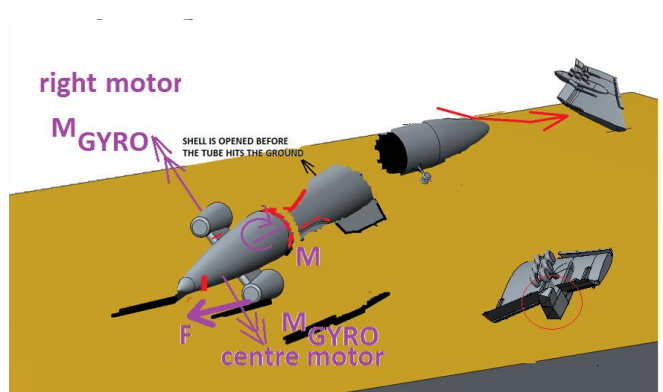
Fig. 19. The drag force imposed on the left motor as it plungers into the ground results in a turning moment  $M$  of the tail section. This causes the gyro moment of the right motor to try to twist the tail sections front part downwards, while the center motor tries to do the opposite. When the gyro moment exceeds the strength of the right motor support, the center gyro motor is allowed to quickly rotate the tail section so the front end of the tail now goes up, thereby damaging the tail rear.
