AN ENGINEERS VIEW ON HOW THE SMOLENSK CRASH COULD TAKE PLACE

Glenn Arthur Jørgensen

Abstract

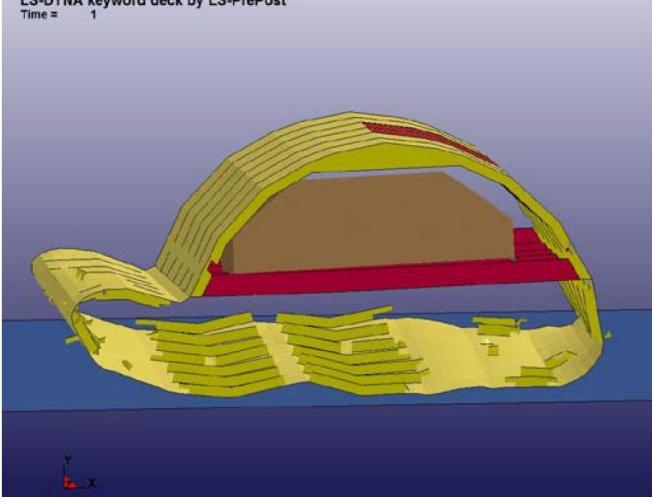
Fig. 3. Simulation of a vertical fall of the fuselage upside down without an explosion [1].

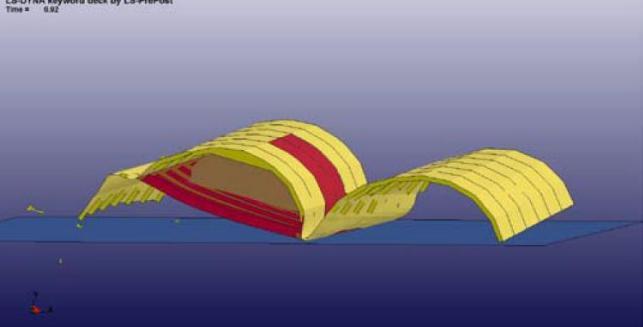
By the official explanation [6] the passengers and crew on board were exposed to accelerations over 100g as the aircraft was destroyed on impact. No explanation in the official reports are given to how such large accelerations can take place without the formation of a crater from the 78.600kg plane hitting soft ground resulting in such 100g accelerations. Solid calculations of the plane hitting the ground resulting in the severe body accelerations show that at least a crater of 1m -2m should have been formed [1]. In [7] the damage of the left wing root and soil on the wheel sides is shown to fit with the hypothesis of a main fuselage explosion occurring at the time, where the ground traces suddenly stop. In [1] it is demonstrated, that the fuselage had to be opened prior to hitting the ground, in order to end with the fuselage sides outwards and not underneath as it actually was found [4] (see Fig. 3, Fig. 4, Fig. 5, Fig. 6). The findings of plane rivet in the body of one of the victims [8]. the total scattering of neighboring plane parts and the findings of burnt aluminum parts and human body parts deep into the ground [9] of the crash site all support the hypothesis of near ground fuselage explosion(s). In [7] the trajectory found through the aero dynamical work show excellent agreement with the three distinct damaged vegetation zones as in the direction of the wind at the time of crash (see Fig. 7). The calculations agree well with a large number of observations and black box recordings, amongst them: The pilots calling a go-around at about H=100 m above the height of runway 26 as of the black box voice recordings, the zones of damaged vegetation, the final velocity towards the ground, the measured GPS positions, the logic and normal approach, the approach as recorded by the TAWS GPS heights and positions, the finding of wing parts prior to the birch tree and hanging loosely on the birch tree, the calculated vertical acceleration, the recorded FMS height and position, the calculated horizontal trajectory, the final heading of the plane, the position of the TAWS 38 event triggered by a "landed" signal, the erroneous behaviour of the left and right elevator signals following the second wing explosion and finally the wing trajectory and ground traces.

Fig. 4. Simulation of vertical fall of the fuselage upside down after the explosion [1].

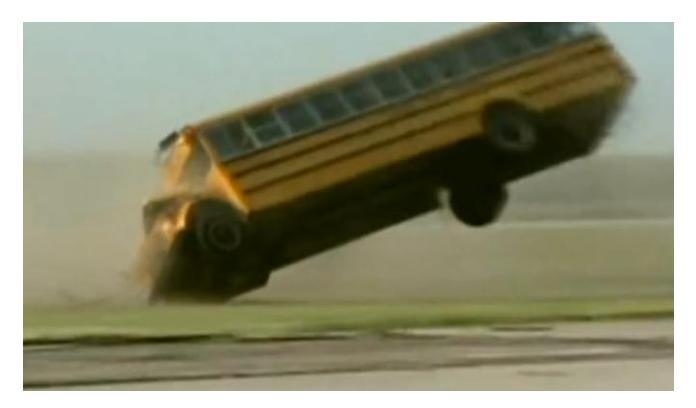
Fig. 9. This bus was pulled 40m behind one 747 engine blowing with the thrust power of the TU-154M. The 11 ton bus was immediately airborne and thrown another 30m - 40m downstream flipping around. See the YouTube video: https://www.youtube.com/watch?v=mj_bB6cUWCs

Assuming a thrust impact zone length of say 40 m, which is a low estimate, the exposure time can be found as $\Delta T =$ 40 m/75 m/s = 0.53 s. Assuming the wood has a density of 800kg/m³, which seems as a high value for the presumably old wood, it is relative easy to show, that the thrust power hitting such fence would accelerate the wood above 17m/s within even the first 0.1s of impact. With otherwords the fence would be torn apart and scattered over a. large area just as the small shacks and the roof of the shacks on the stated path of the plane flying past the claimed birch tree. The power of turbine engines is illustrated in [13], where first a classic American 11 ton school bus is towed 40 m behind the engine of a 747 plane. One 747 engine has approximately the same thrust power as all three TU-154M engines. The bus immediately becomes airborne (see Fig. 9) and is tossed 30-40 m downstream.

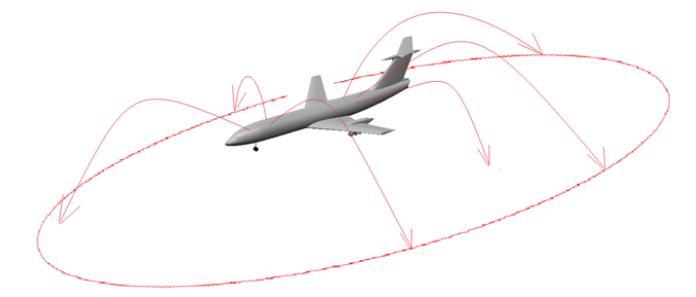
Fig. 11. Fuselage explosions occurring when the plane is in a normal flying position will tend to send parts upwards and

outwards due to the main structure of the plane (passenger floor) acting as a shield and directing the pressure wave in this direction.

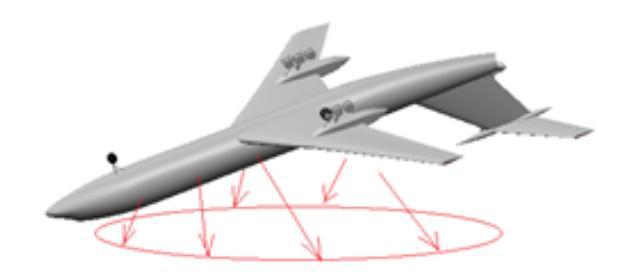
Fig. 12. Fuselage explosions occurring when the plane is in a upside down position will tend to send parts downwards into the ground due to the main structure of the plane (passenger floor) acting as a shield and directing the pressure wave in this direction.

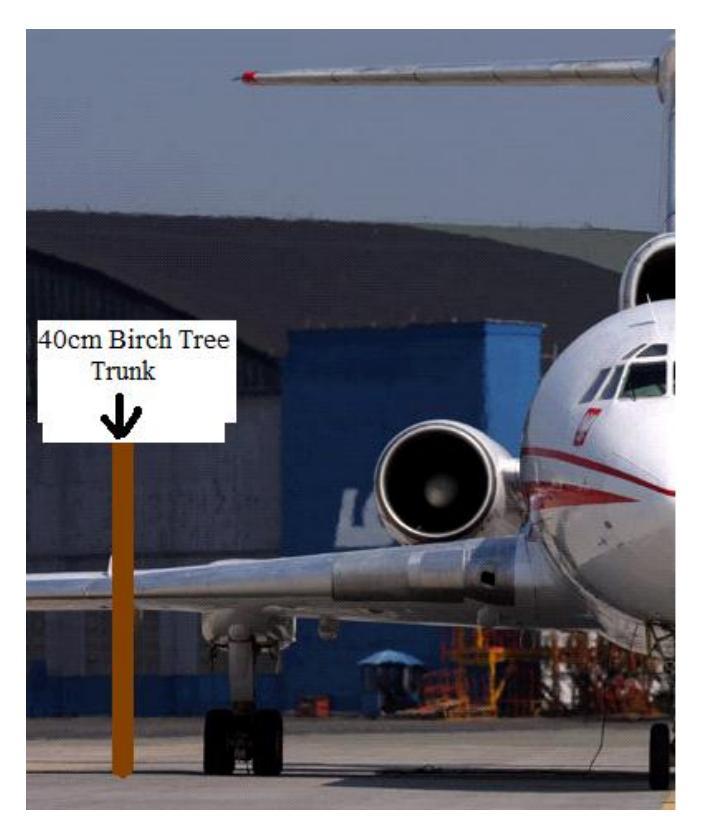
The aerodynamics [2, 5, 14] show that the loss of lift on the one side needs to be substantial and corresponding to about 10m of the wing length to ensure the plane will crash. The engineering challenge being, that the wing at this point is about 0.5m thick and 4.5m wide and the obstacles nearby the airfield only consist of medium sized trees and a single metal mast. It would not seem very likely, that a say 30-40cm birch tree (as claimed in [6]) or small metal mast structure would be able to cut through such massive aluminum structure built to carry 100 tons hitting at high speed. The proportions are shown in Fig. 13. The answer to this is therefore to cut the wing further towards the wingtip where it is thinner and less wide, and then removing the required additional wing loss in a separate operation. Cutting the wing with a sharp cut, can easily be done by the use of explosives using a directional type explosives developed by the military and used for many years (see Fig. $14 \div$ Fig. 17). This would require the wing is taken apart and the explosives planted inside the wing. Here they are not likely to be exposed during the period from implementation and usage as this is inside the fuel tank and not easy to inspect in a normal routine check. The main challenge in cutting the wing being, that the slats located at the front edge of the wing are outward moving parts and any explosives needed to cut these at the desired position would easily be detected. The answer to this challenge is to take advantage of the natural points of division of the slats, where two neighboring slats are pushed towards each other.

Fig. 13. The birch tree claimed to have cut the wing was 30cm - 40cm in diameter. This is illustrated together with the wing of the TU-154M at the point the wing needs to be cut to force a roll of the plane as logged by the black boxes.

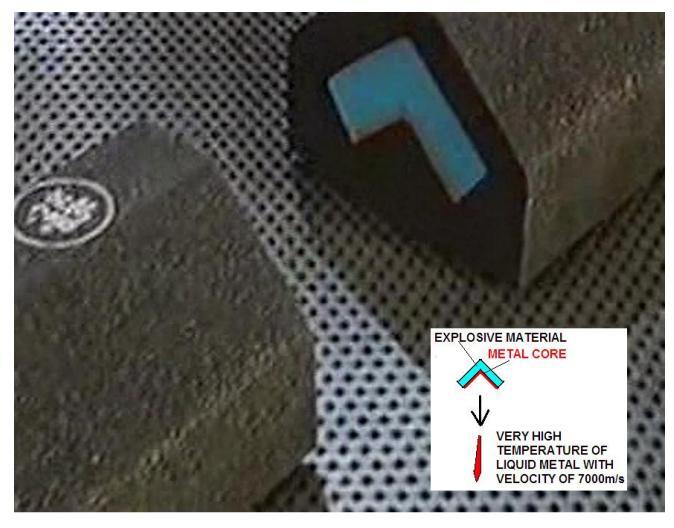
Fig. 14. The directional type explosives will send a liquid metal off with 7000 m/s cutting through almost anything. They can be formed in almost any shape and are found in a large variety of sizes. The metal core is typically copper but can also be aluminum. Traces of the metal will be found on the edges of the cut (exploded) parts.

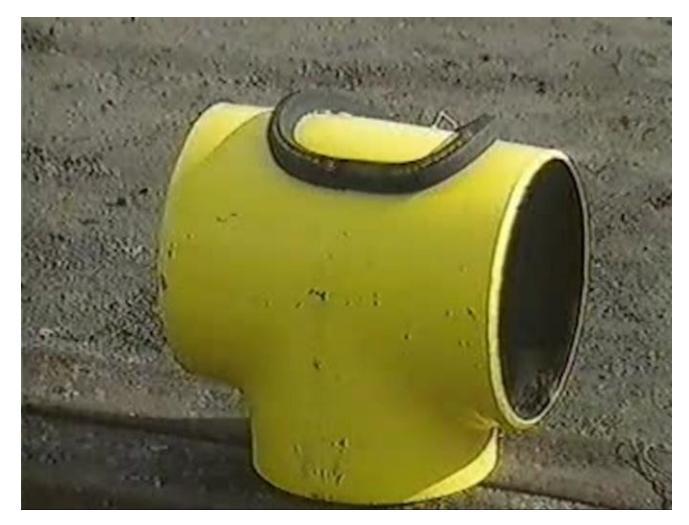
Fig. 15. The explosive can be formed in almost any shape. Here prepared to cut through a steel pipe [15].

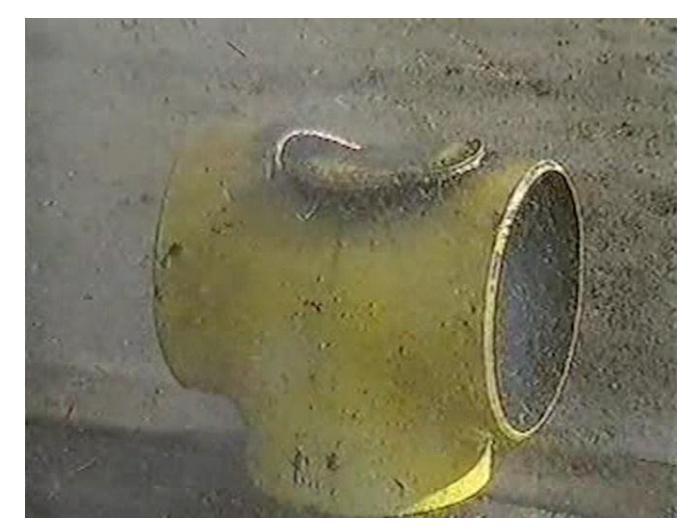
Fig. 16. The circular hole is cut with a sharp edge without throwing the parts around. Traces of the metal core of the directional explosive will deposite on the edges of the cut surfaces, in this case copper. Directional explosives can be found, where the metal core is aluminum matching the material of the wing better. The remainings of the plane will therfore contain valuable investigative information.

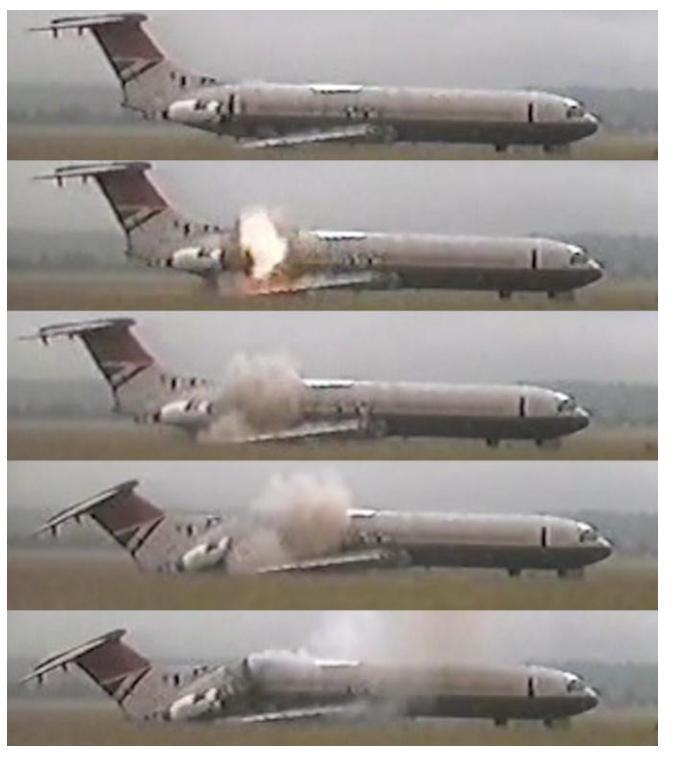
Fig. 17. An experiment performed in 1991 by the British Defense Research Agency [15].

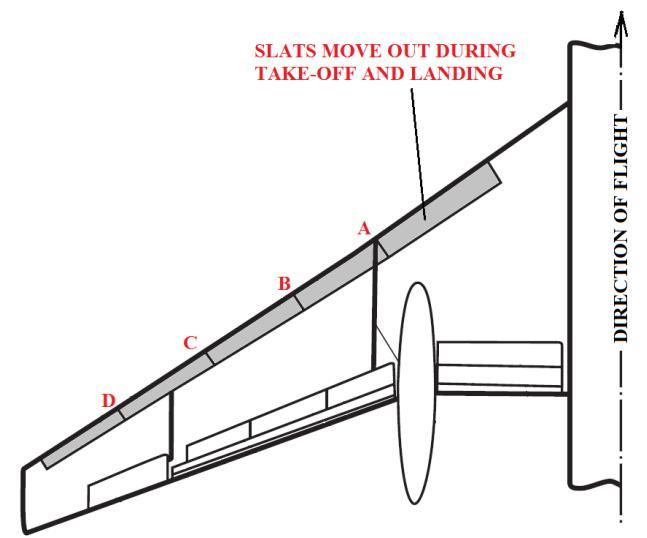
Fig. 18 shows the location of these points, and consideration is required to determine which of the four points to choose. The points noted as "A" and "B" are not good choices, as the wing is thick and wide here. The point "D" is not an option either, as the resulting lost wing area would be very minimal and the resulting angle of cut way out of line with the direction of flight. This leaves point "C" as the only point where to fake the cutting obstacle (tree/mast) <u>entered</u> the wing at the leading edge.

Fig. 18. The slats move out during take-off and landing, and cutting these moving parts with explosives would be complicated and invovle a big risk of detection. At the points A to D a natural division already exists from manufacture [16].

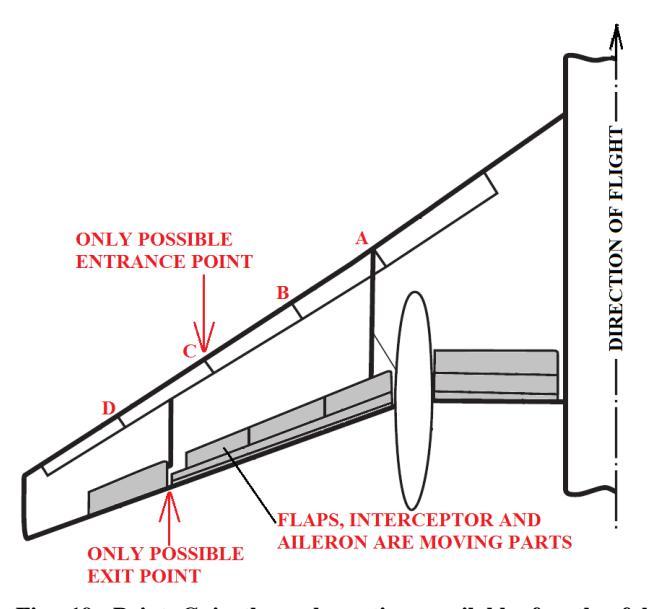
Fig. 19. Point C is the only option available for the fake entrance. On the trailing edge the aileron, flaps and interceptors are moving parts, and cutting through these moving parts with explosives would be complicated and invovle a big risk of detection. The only possible exit point is between the outer interceptor and aileron.

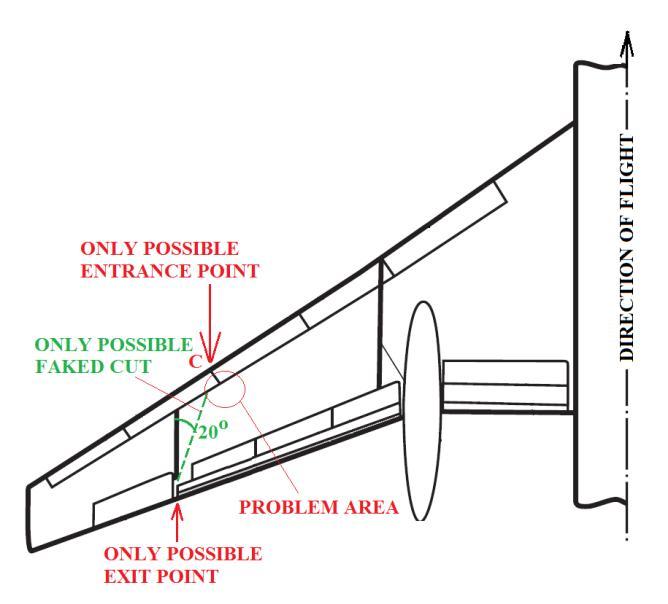
Fig. 20. The green dashed line shows the only possible choice of the faked cut. This line makes an angle of about 20° with the direction of flight. Note also there is expected to be an unavoidable problem area marked with the red circle, where the edge of the slat does not fit with the line of cut.

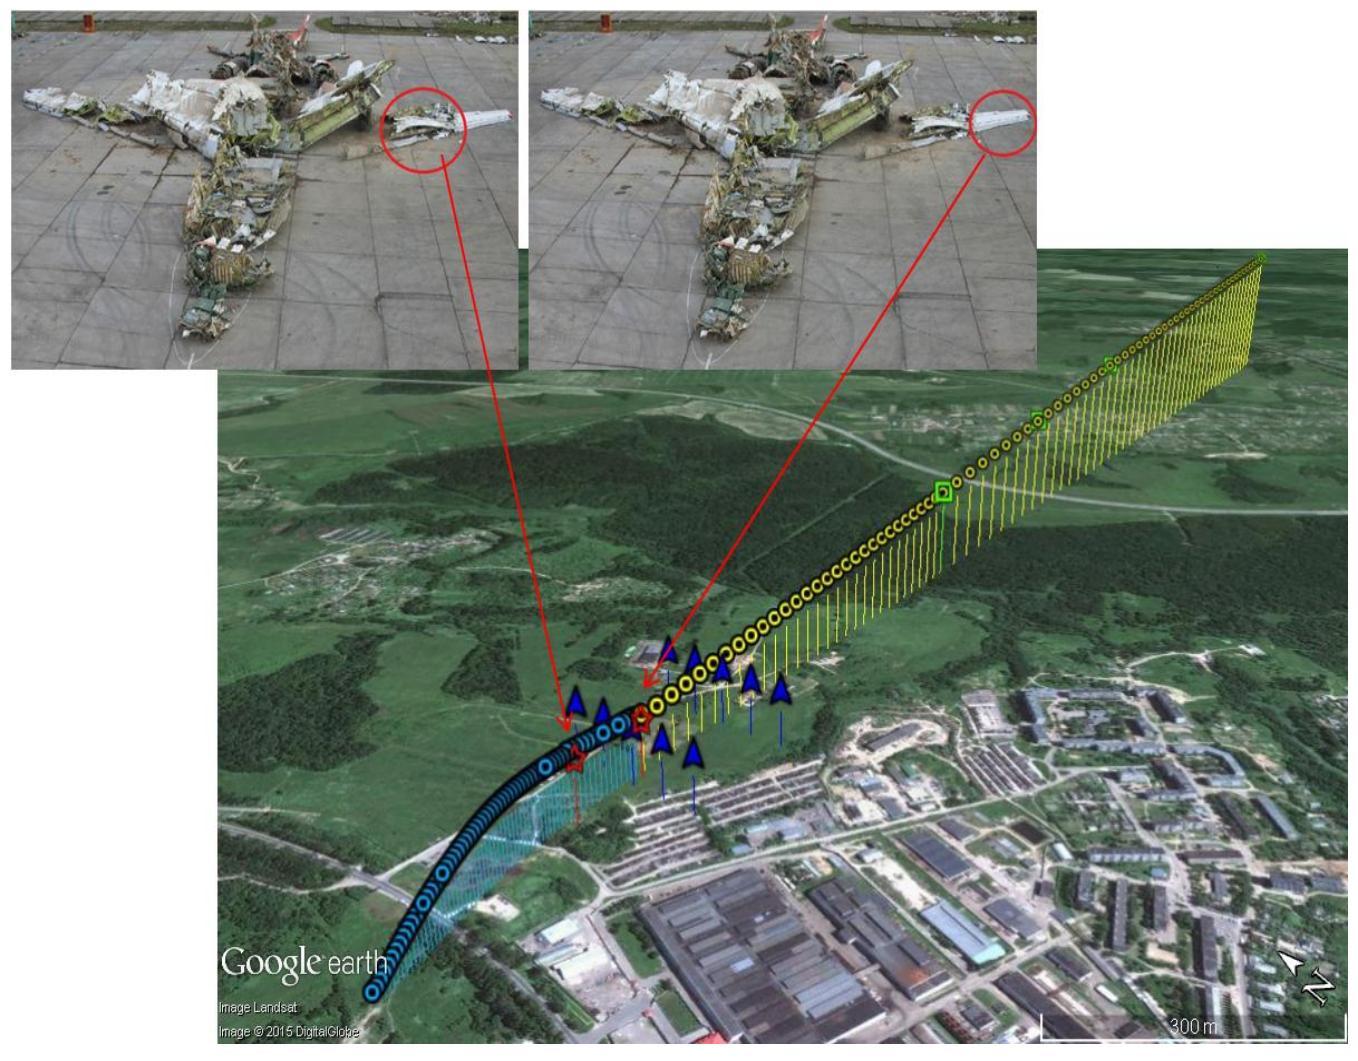
Fig. 23. The plane can be brought to crash at the desired location for the entire range of heights. All the planner has to do is rely on the competent pilots bringing the plane within the upper and lower glide paths, of course aided by the tower tracking the planes height by radar and ground personnel, and keeping the plane "on course" and "on path". Here is shown where the wing tip was lost and where the central wing part was damaged. The green squares are GPS logged positions and heights and the blue triangles show the middle marker entry and exit [7].

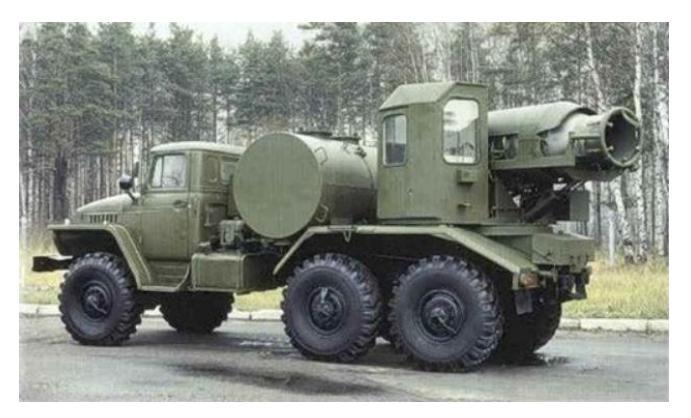
Fig. 25. An earlier serial produced version of the Russian truck based TMC65 fog generator.

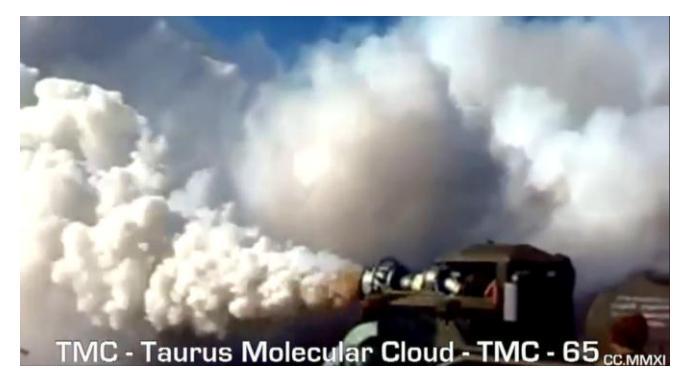
Fig. 26. The newer Russian TMC fog generator in action. For video see [18].

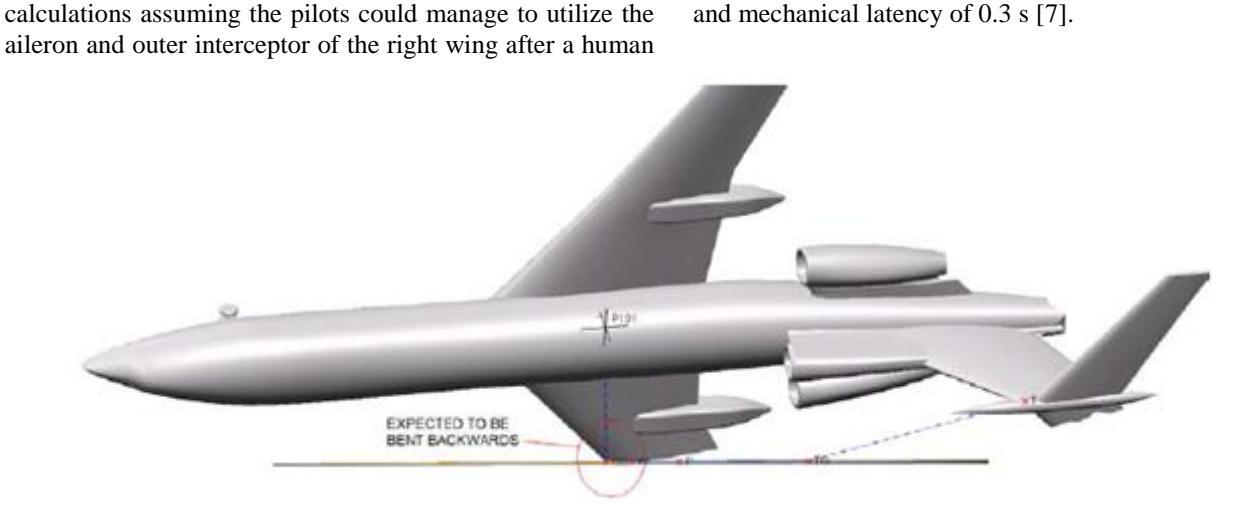
Fig. 27. The corner of the shortened left wing is expected to be bent backwards when making ground contact.
