# MAJOR ERRORS OF THE OFFICIAL RUSSIAN AND POLISH INVESTIGATIONS OF THE SMOLENSK CRASH

Glenn Arthur Jørgensen

#### Abstract

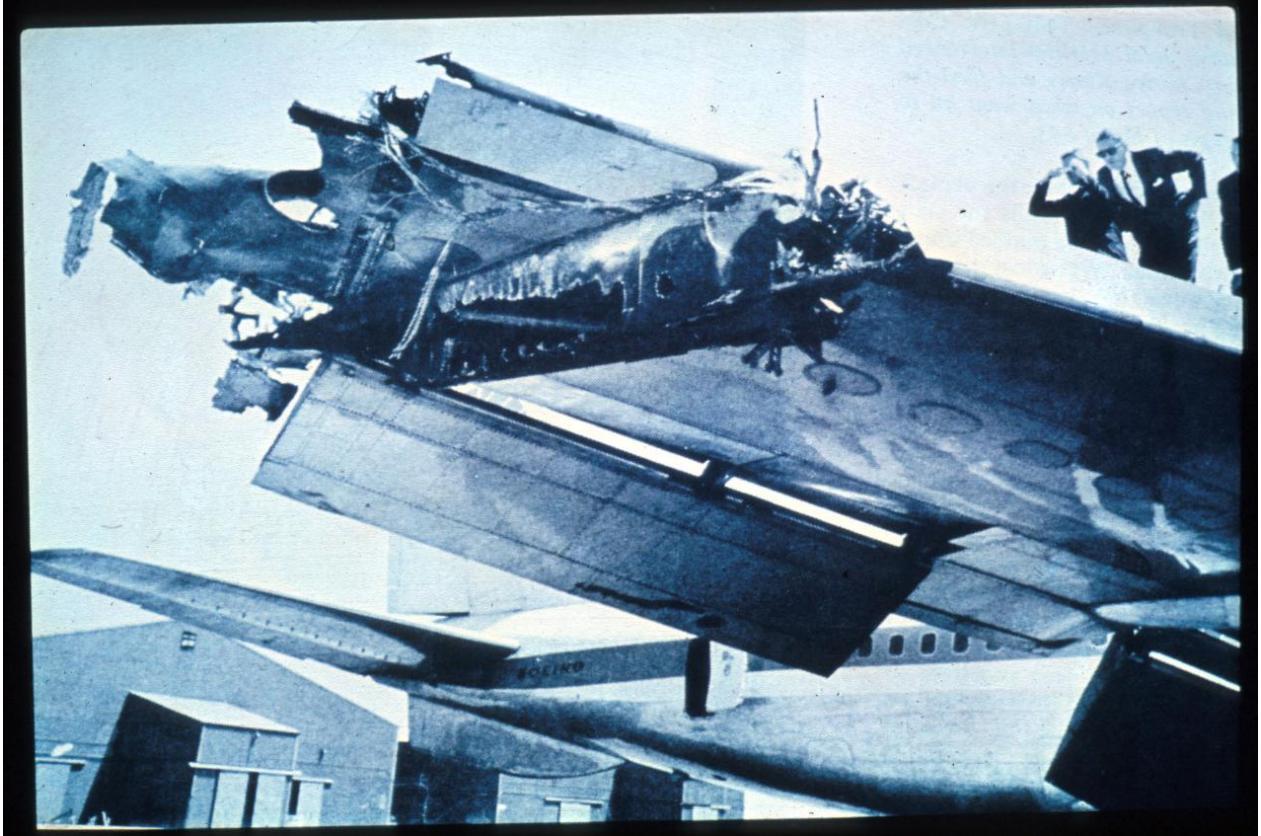
Figure 1. Photo with courtisy of Frank Taylor of one B707 that lost 7.6m or about 19% of it's wing span, flew 24min and landed safely.

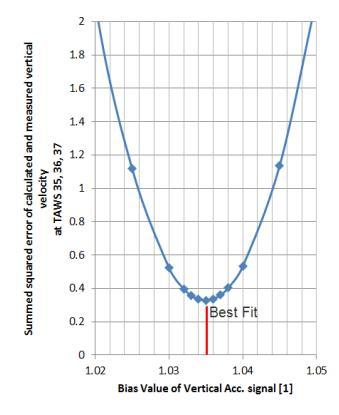
For the first time trajectories of the final minutes of flight are based on a technique that utilizes the height changes as measured by the three GPS units and recorded at the TAWS 34 to TAWS 37 events together with the logged vertical speeds to strongly reduce the effect of the various sources of error on the vertical acceleration sensor data, allowing for an accurate determination of the planes height through a double integration. The bias is found that gives the best agreement between the calculated velocities based on the integration of the accelration data and height changes through minimizing the least squared error. The bias leading to the best agreement between the calculated and measured height change as a function of time can be seen in figure (Bias=1.035 or b=-0.035). The resulting trajectory is shown in figure (black line). This agrees completely with the trajectory found through aerodynamics and presented at the recent Smolensk conference. A Monte Carlo analysis shows, that the plane with 99.9% certainty flew more than 28m above the ground of the birch tree claimed to have cut the wing at 5m height. [21].

With other words two totally different methods based on two independent sets of data both tell within a few meters the same position of the plane 57m above the runway altitude, when it lost the first part of its left wing. No obstacles exist at this height.
